Conservation Plan  
for the  
Great Western Steamship Company Dockyard  
and the  
*ss Great Britain*

Volume 2 - Condition Report and  
Recommendations for the *ss Great Britain*

Prepared by Eura Conservation Ltd  
and the *ss Great Britain* Project

December 1999

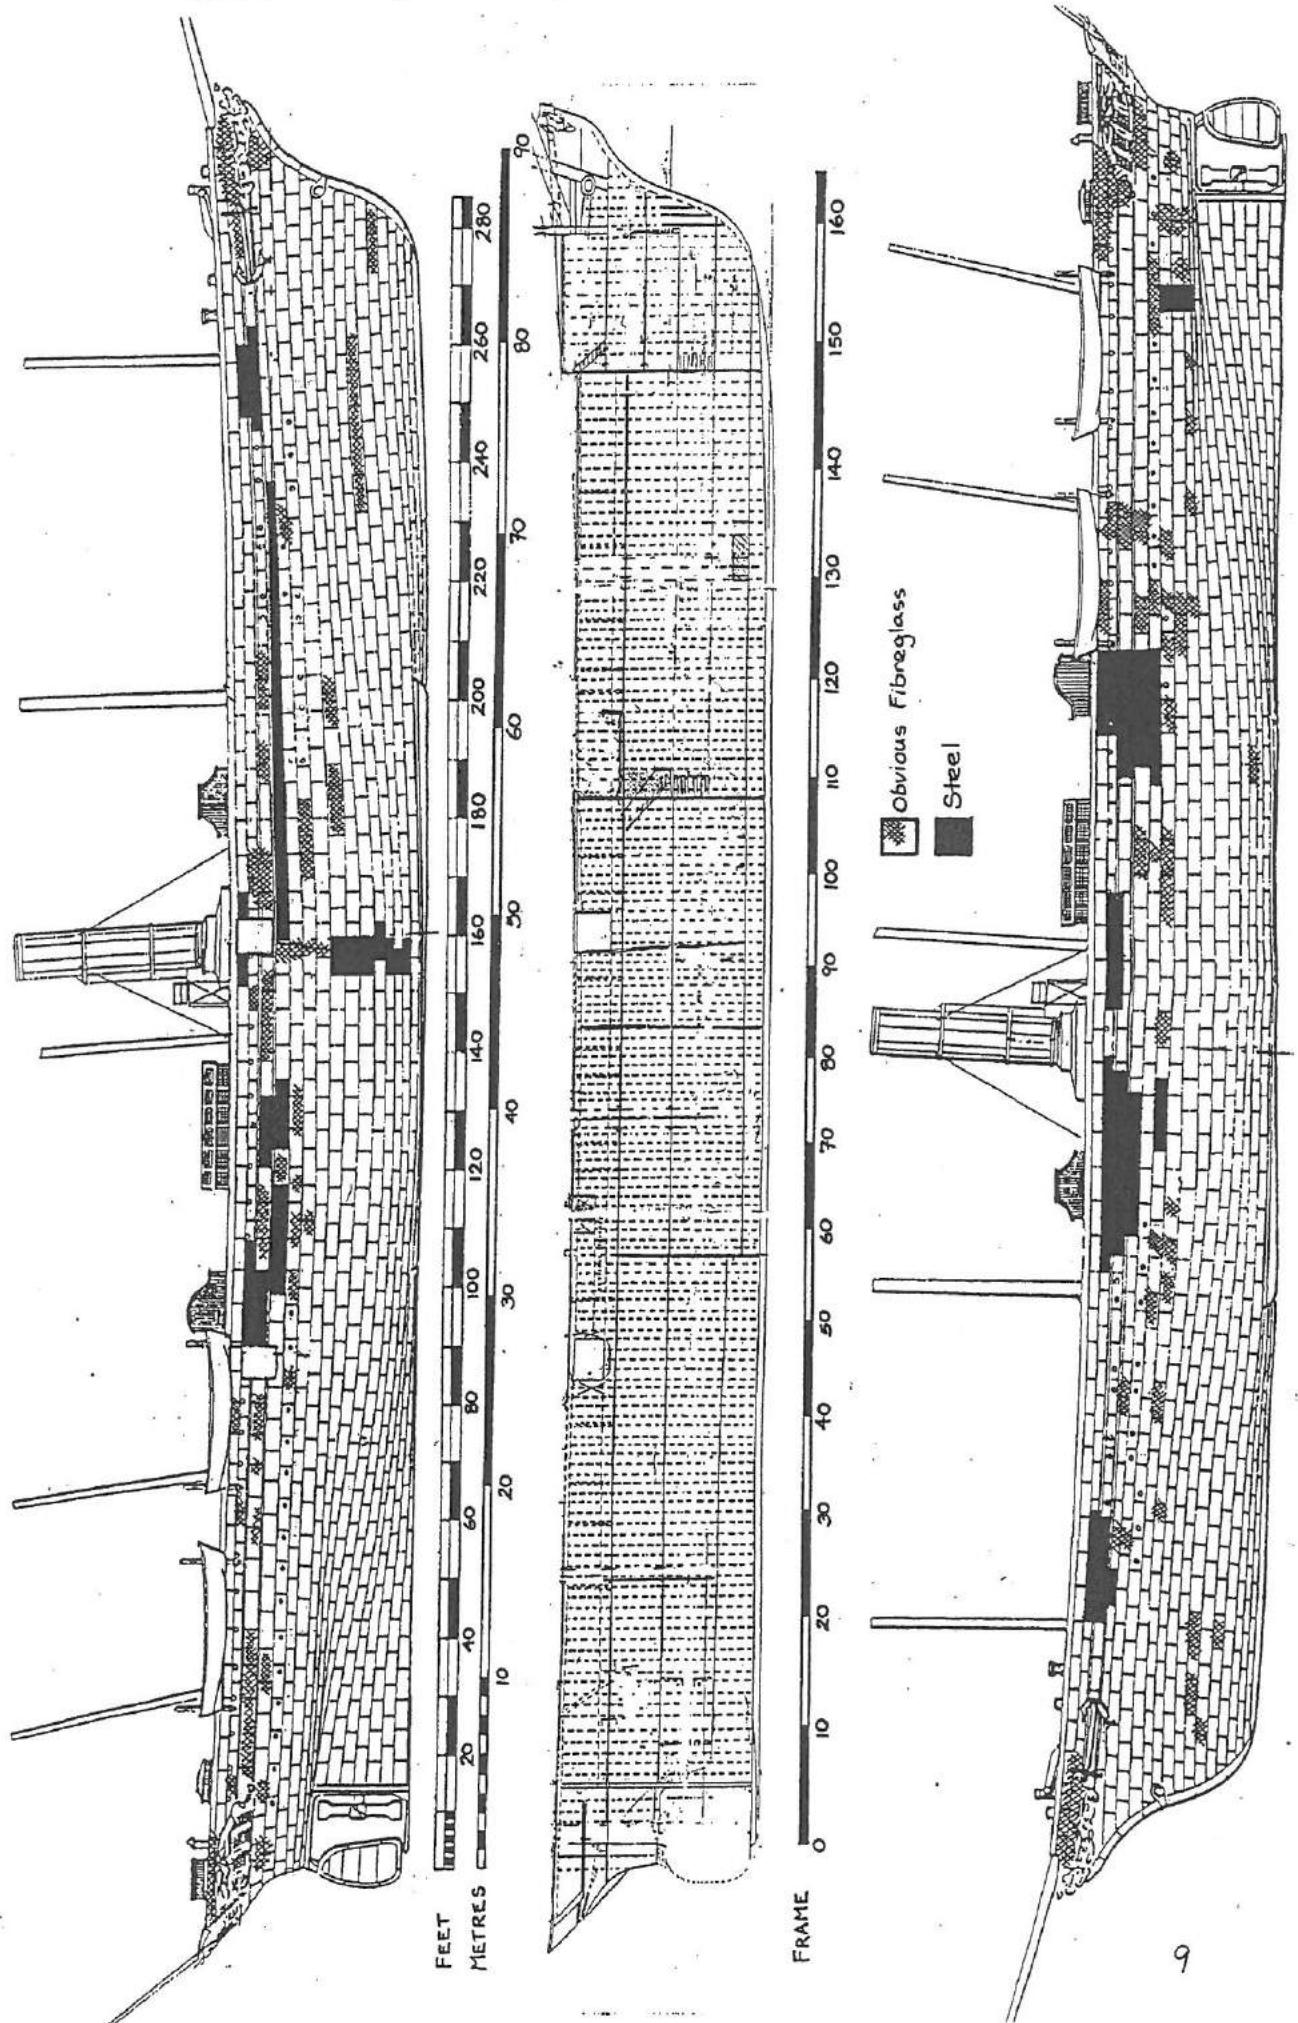
Figure 3

Diagram showing relative areas of iron, steel and fibreglass

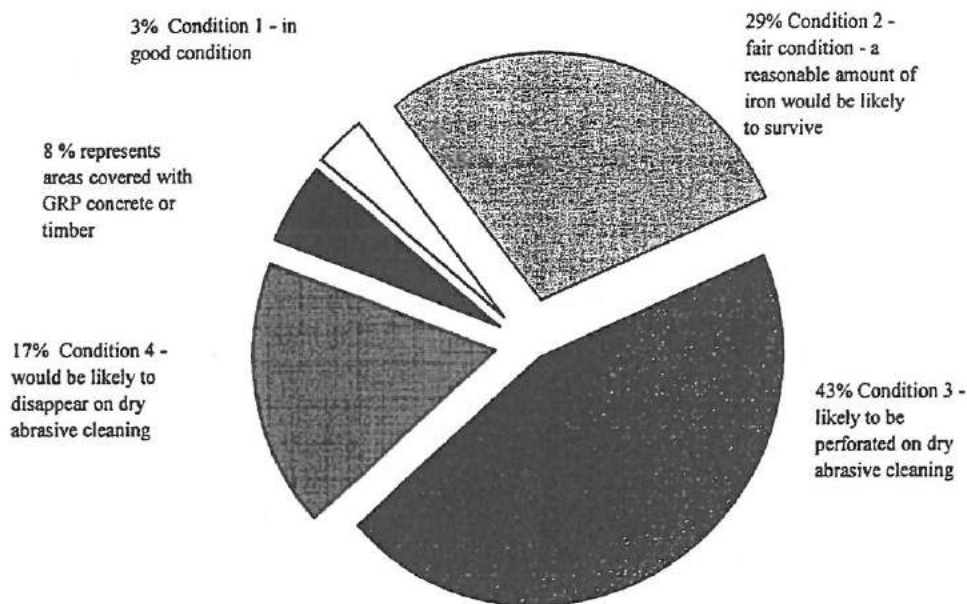
Figure 4 – Condition of all tested plates

- 6.8. The survey largely confirmed what was visible externally. It shows that the ironwork below the waterline is generally in poor condition, with spalling, friable corrosion products and exhibiting signs of substantial chloride accelerated corrosion, inside and out. This is particularly bad under the docking keels. It further confirmed that the traditional 'shipyard' cleaning approach to which the ship has been subject over the past 30 years has been largely unsuccessful in stabilising the ship's corrosion. The survey showed that there had been considerable deterioration in the hull fabric over that time.

- 6.9. The survey results in particular show that:
- 6.9.1. Of the hull plates examined, about 17% are graded as 'condition 4', displaying very severe corrosion, with parts missing. This plating is likely to become lace-like or non existent if it is dry-blasted at a pressure sufficient to remove the corrosive products, or if it is cleaned with abrasive methods;

- 6.9.2. A further 43% are graded as 'condition 3', displaying severe corrosion, and likely to be perforated and degraded by abrasive cleaning;
  - 6.9.3. In about 28 % of the hull plating examined, there was found to be corrosion, but the plates probably had sufficient iron remaining to withstand dry blast cleaning (condition 2);

- 6.9.4. Only 3 percent of the hull plating examined was found to be in comparatively good condition with a strong probability of a reasonable amount of material remaining (condition 1).

- 6.9.5. The condition of the hull, both port and starboard, was roughly comparable in terms of the extent and nature of the corrosion product, with no discernable patterns emerging

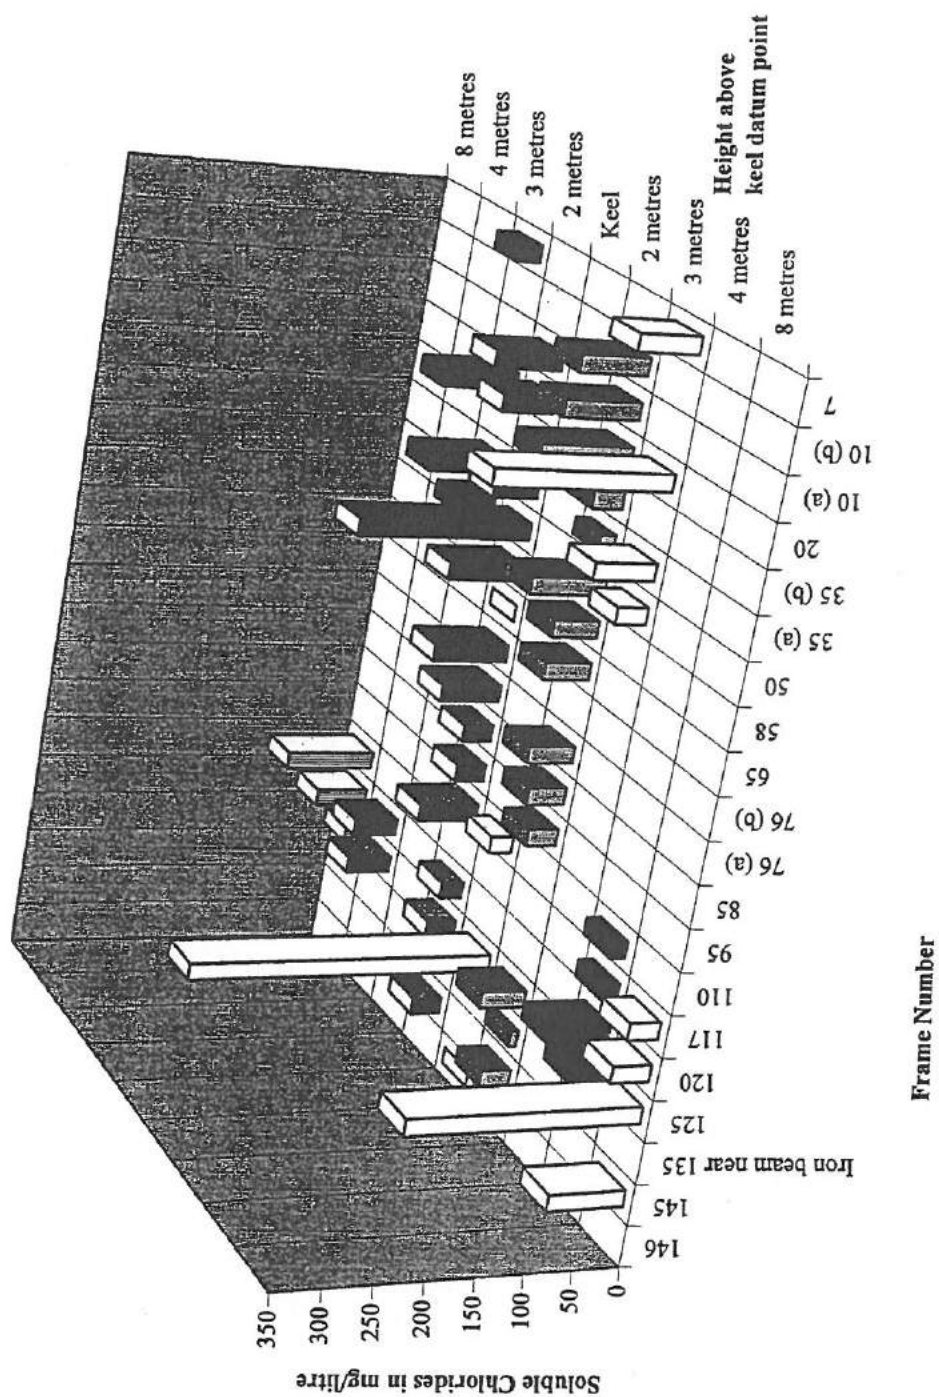
**Figure 5 - Soluble Chloride Contamination**

Soluble chloride levels are being measured on 2, 3, 4, 6, and 8 metre waterline intervals throughout the hull, measured from a datum on the keel near the mainmast. Where the same frame is shown as (a) and (b), two independent tests were made.

- 6.38 Internally the distribution of chlorides showed little consistency longitudinally or in waterline heights. It is present from stem to stern, and keel to 10 metre level, with high and low readings almost side by side. No trends were apparent. The whole interior of the vessel is contaminated to various degrees.
- 6.39 Some of the highest chloride levels were recorded in samples from within the iron box girder at the 8 metre level. This reading was probably due to the fact that these areas acted as dams or water traps, and may never have been adequately flushed with fresh water as was the rest of the hull.
