SS GREAT BRITAIN DECK DRAINS - PRESENT AND FUTURE

Report on leaks into the ss Great Britain's Promenade deck from the weather deck -
Shane Casey, 1999

SS Great Britain - Report on Water Leaks

ss Great Britain - Condition Survey Soluble Chloride Contamination

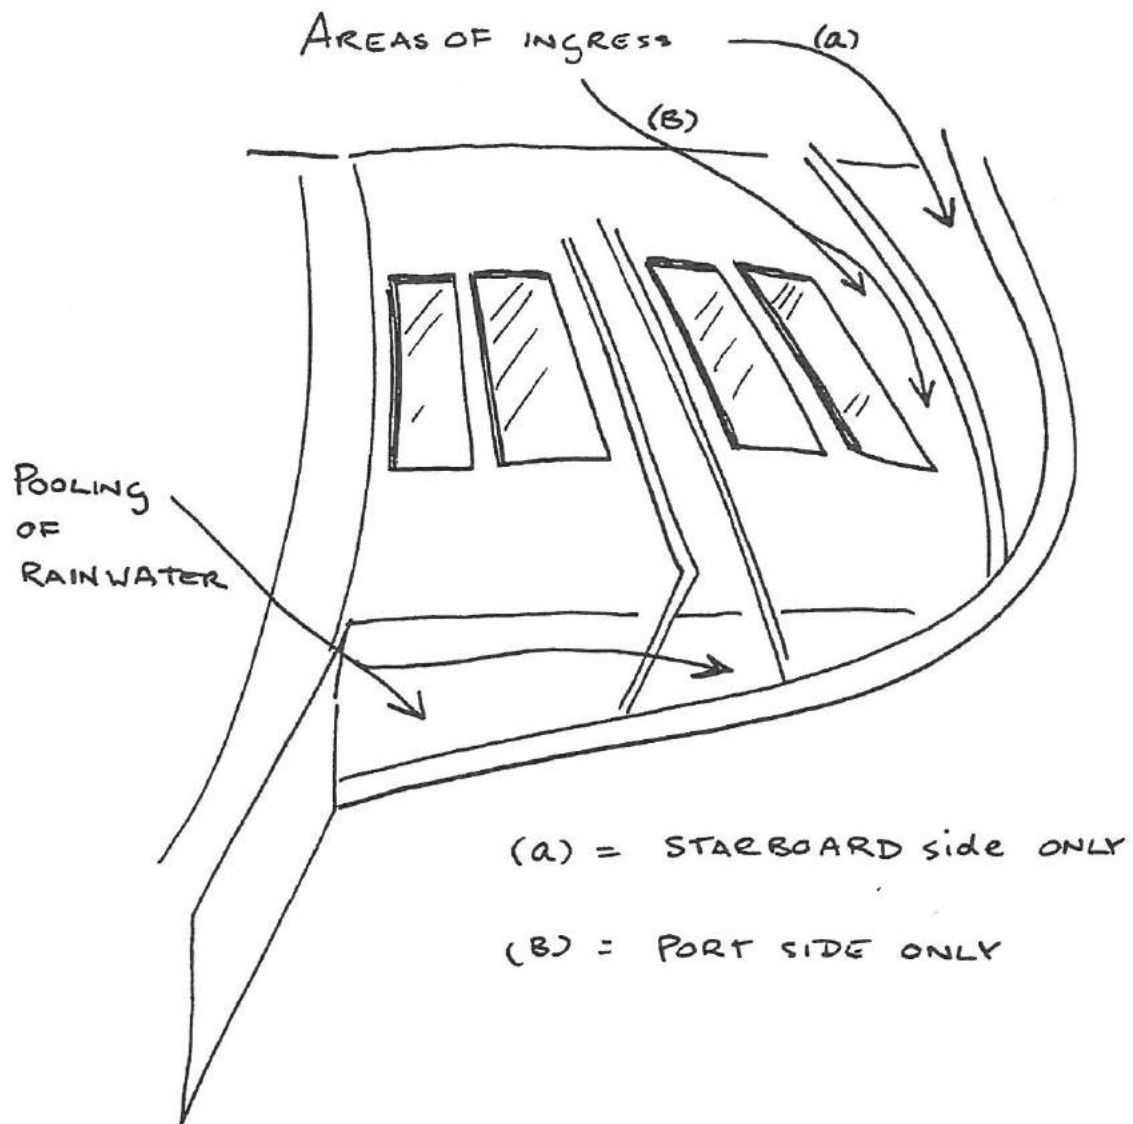
LEAKS 1 & 2

Leak Number	Area in which leak was observed	Description of the leak
1	p/minus 1/8.5	Pin prick hole at butt strap
2	p/minus 3/8.5	Extreme rear of ship. Leaks in hull plating under paint, puddles forming. Leaks through weather deck causing corrosion of new metal deck edges, where they butt the wooden bulwark
3	p/3-5/8.5	Promenade deck. Pin prick holes in hull plate or fibreglass producing rust staining on paint.
4	p/7-8/8.5	Promenade deck. Small leak from port hole
5	p/50/8.5	Promenade deck. Port hole in passenger cabin showing signs of mold
6	p/73-74/8.5	Leak through hole in hull plating, behind sponsorship board
7	p/76-77/8.5	Leak through hole in hull plating, near to box girder
8	p/skylight 1	Crack in port forward pane of glass
9	p/skylight 1	Small leak on starboard side
10	p/skylight 2	Leak from centre of skylight
11	p/skylight 3	Leaks from centre
12	p/skylight 4	Small leaks port and starboard. Not running onto floor

SKETCH VIEW OF STERN SHOWING
RAIN WATER INGRESS.

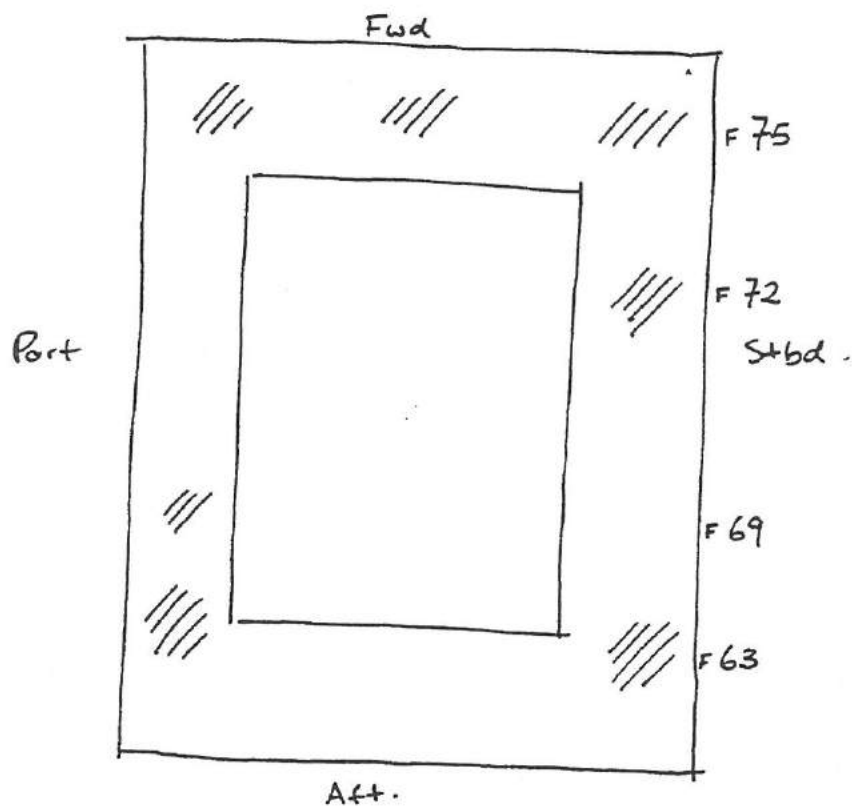
LEAK NO 55
Plan view, Engine Skylight leaks

46	p/159/10	Drip through crack in weld line in new metal weather deck
47	p/162/10	Leak through hull plating, around iron bolt in wooden blocking
48	p/164/10	Leak through wooden blocking joint between 3 rd and fourth block same as on starboard side.
49	p/164/weather deck	Puddling at junction of concrete and wood decks
50	p117-118/8.5	Top of longitudinal box girder wet. Source unknown, but probably as for (15)
51	k/100/weather deck	Glass lenses in ventilator grids forward and aft of funnel leaking, dripping into cut-out in wooden deck, onto steel deck below
52	k/147 Centre of ship.	Heavy dripping noise onto main deck? Couldn't see drip but could hear 2-3 heavy drips every second
53	k/155/8	Drip from deck above, through junction of old and new deck beam angle iron
54	k/162/8	Drip from deck above, forming puddles on shelf at extreme bow
55	k/94-95/skylight 6 over engine	Extensive leaks.
56	s/75-76/8.5	Leak through Port hole

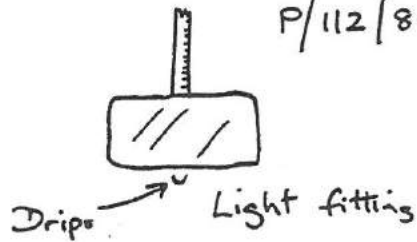
P/112/8.5 Leak No 15

Leak Number	Area in which leak was observed	Description of the leak
14	p/107-109/8.5	Promenade deck curved overhead stringer plate - extensive leaks
15	p/112/8.5	Drip from light switch. Source unknown, probably junction of bulwark and steel weather deck
16	p/116/8.5	Drip from promenade deck curved overhead stringer plate. Source unknown, but probably as for 15
17	Main mast	Aft side, rivulets running down mast, and drips onto mast partner
18	p/116/skylight 7	Drips from dead centre of skylight, next to mainmast. Constant drip
19	p/120-121/8.5	Top of longitudinal box girder wet. Heavy constant drips from upper deck curved overhead stringer plate
20	p/122/skylight 8	Drip, not constant, onto hull plating at 2 meter waterline
21	p/122-123/8.5	Drips on forward side of mid-frame 'frame'
22	p/123-124/8.5	Leaks from port hole and through rivets in hull plating. (Bad leaks)
23	p/125-126/8.5	Top of box girder wet. No obvious source

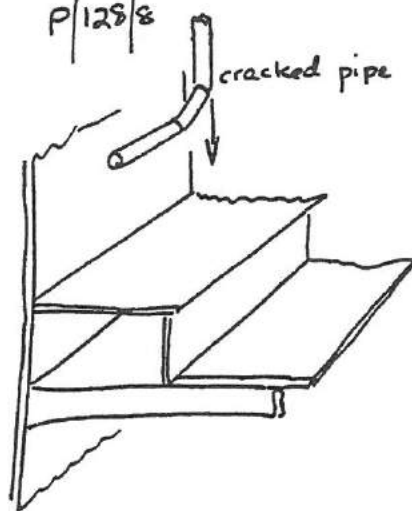
Leak No 24

24	p/128-129/8.5	Grey drain pipe elbow cracked and leaking. Bad drip onto shelf next to box girder. Subsequently fixed.
25	p/130-131/8.5	Drips from promenade deck curved overhead stringer plate onto box girder
26	p/132-133/8.5	Drips from promenade deck curved overhead stringer plate onto box girder
27	p/134-135/8.5	Slight leak from hull plate. No hole obvious, but leak is running onto butt plate
28	p/134-137/8.5	Constant heavy drip from promenade deck curved overhead stringer plate onto box girder
29	p/136-137/8.5	Leaks through port hole and rivets
30	p/137-138/8.5	Leaks from Lead scupper. Heavy drip
31	p/138-139/8.5	Drips from promenade deck curved overhead stringer plate and possibly rivets at butt pad. Too wet to tell exact location
2	p/139-140/8.5	Drips from promenade deck curved overhead stringer plate
33	p/141/8.5	Drip from promenade deck curved overhead stringer plate Unknown origin, onto shelf next to box girder.

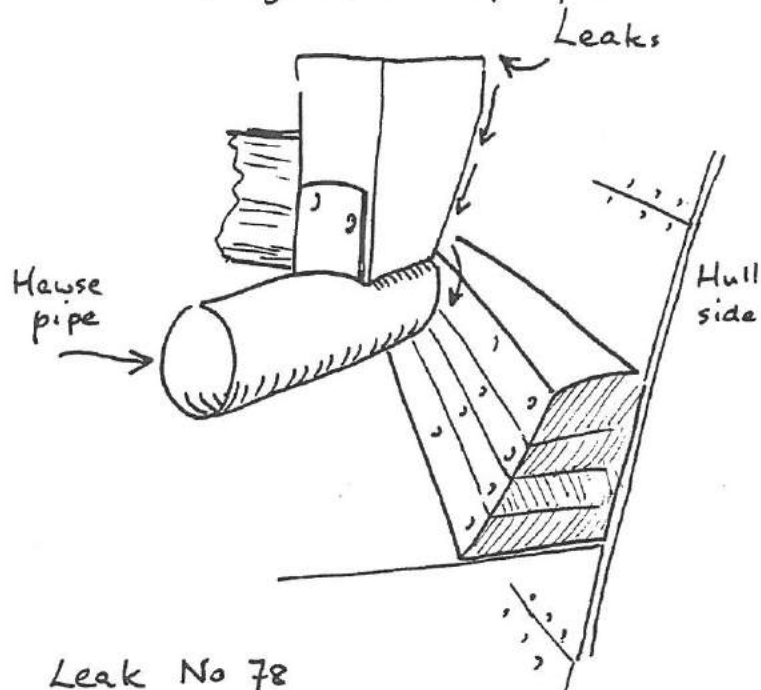
Knightheads S/161/10.

Leak Number	Area in which leak was observed	Description of the leak
81	s/157-158/8	Leaks through hull plating next to frame
82	s/158-159/6	constant leak over wide area, no obvious source
83	s/158-164/10	Leaks from weather deck on side of bulwarks directly onto hull plating
84	s/160-161/6	Constant leak over wide area, no obvious source
85	s/160-161/8	Leaks through hull plating next to frame
86	s/161-162/10	Leaks around starboard side of starboard knighthead, onto iron hawse pipe, and thence leaking onto wooden blocking on interior starboard side of bow
87	s/163/10	Leak through wooden blocking joint between 3 rd and fourth block (no 4 being that which rests on the floor of the forecastle.
88	s/164/10	Leak through hull plating, around iron bolt in wooden blocking at extreme forward side of bow
89	s/164/weather deck	Puddling at junction of concrete and wood decks

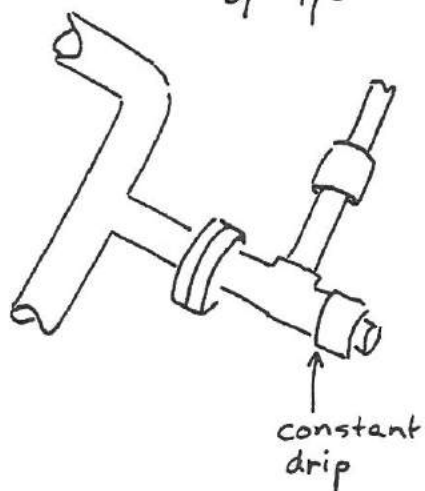
Leak No 78

71	s/127-129/8.5	Promenade deck curved overhead stringer plate, and rivulets of unknown origin down hull plating. Damp, but not too bad
72	s/130-131/8.5	Hull plating wet, source unknown, probably bulwark
73	s/132-136/8.5	Leak through hull plating and from promenade deck curved overhead stringer plate. Heavy drips
74	s/137-138/8.5	Scupper. Very bad and frequent drip
75	s/138-139/8.5	Bad drip from promenade deck curved overhead stringer plate - every 2 seconds
76	s/146-147	Torrent of water on outside of drain pipe. Box girder, hull plate wet. Subsequently repaired.
77	s/147/-148/10	Drips through coopered ceiling of companionway hatch cover.
78	s/147/6	Drain pipe elbow leaking badly
79	S/147-148/10	Direct entry of rain into forecastle through open companionway door. Water running onto forecastle deck, leaking through planking to decks below
80	s/150/8	Leak through Forecastle deck planking onto deck of lower forecastle

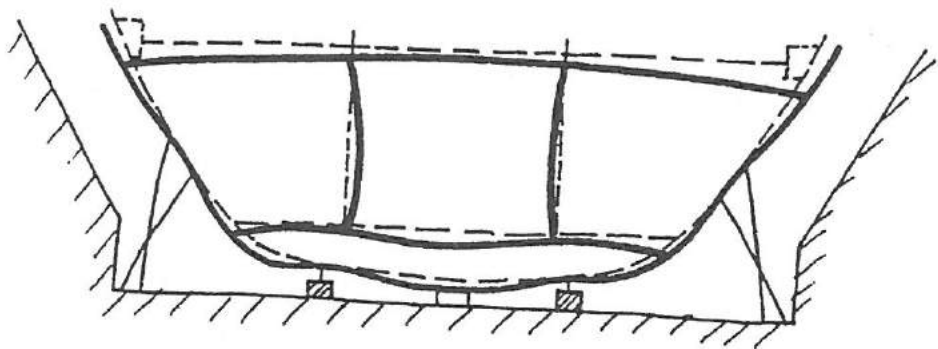
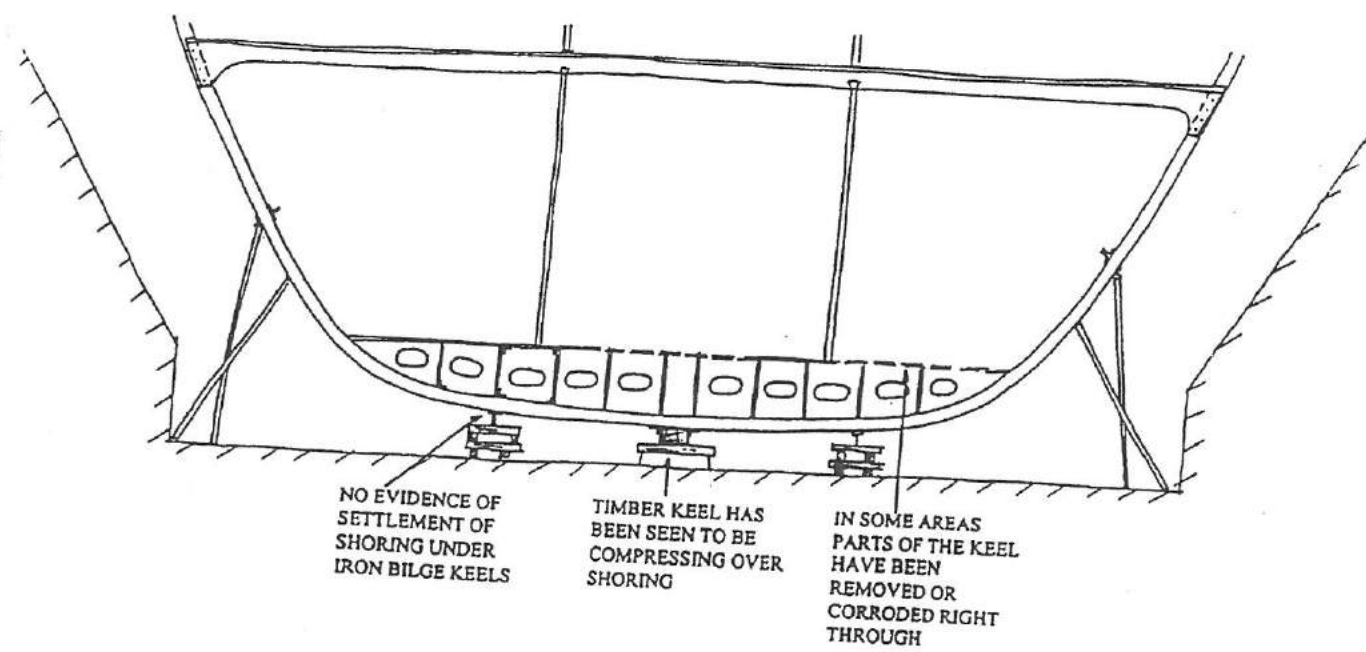
TYPICAL SECTION THROUGH HULL SHOWING ASSUMED EFFECT OF DEFECTS ON HULL OVER TIME (EXAGGERATED)

- 4.7 Our overall concern relates to the fact that as the material wastes its strength will significantly decrease. The majority of the decay relates to the hull where the strength of the frames is compromised by the partial or complete loss of the up stand leg. With the similar reduction in thickness of the plates the load from the upper sections of the hull, where the condition is not as poor, may cause the lower section to start buckling.

3.4.3 There appears to be a slight bulging of the hull to the starboard side amidships. This may be caused by a loss of support to the hull ribs.

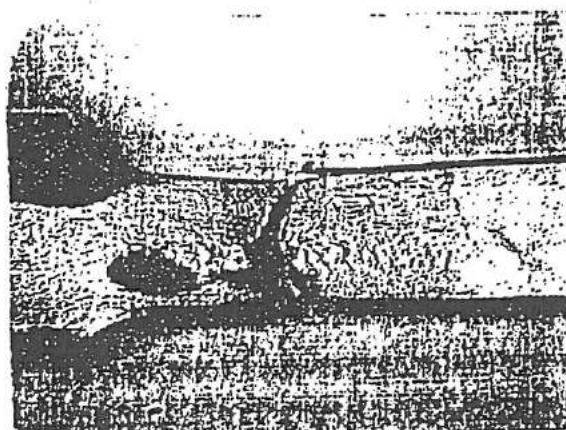
Fig. 5

The bar seen in Fig 3. was subsequently machined into tensile specimens which were each tested in the normal way. Not surprisingly, the specimen from the centre of the bar, where some segregation had been previously seen, broke at a low stress in the welded region. Of the remaining two specimens, however, where the weld looked sound, one broke in the gauge length, initiated at a large slag inclusion, (Fig. 5) while the other, surprisingly, broke once again with a low stress at the weld interface (Fig. 6).

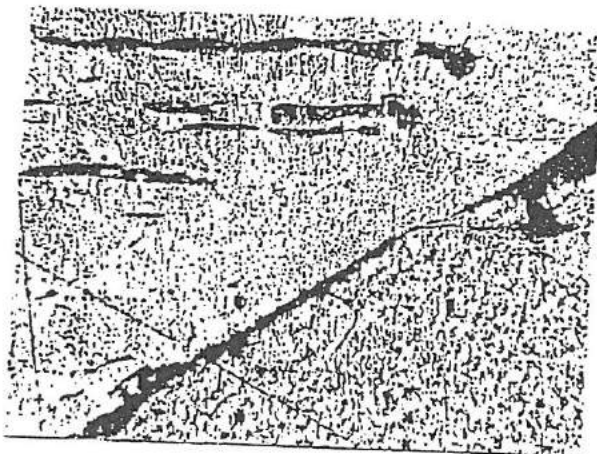
Fig. 7

Upon closer examination it appears that during the welding process, the slag in the wrought iron melts and can, as a matter of chance, resolidify in a position where it sits across the join between the weld metal and wrought iron (Fig. 7).

In other words, the resolidified slag creates a weak layer almost exactly at right angles to the worked slag stringers in the original bar, and in so doing almost exactly replicates the weakening effect of the slag identified as harmful in electrically welded wrought iron in 1935.
