ss Great Britain Project Brief for Preparation of a Condition Report for the ss Great Britain

2.1. The Condition Report will examine the ship known as the ss Great Britain, which is defined as the ship created by I.K Brunel and his collaborators and launched in 1843, until the end of her working life as a ship, hulk or wreck in 1970.

Site visits were conducted to the SS Great Britain, Bristol Historic Dockyard by our engineers on the 29 and 31 July 1998 in order to remove samples of structural material and assess the load bearing wooden supporting struts. In addition to this inspection and testing was carried out to determine the condition of the coffer dam used to secure the dry dock in which the ship is berthed.

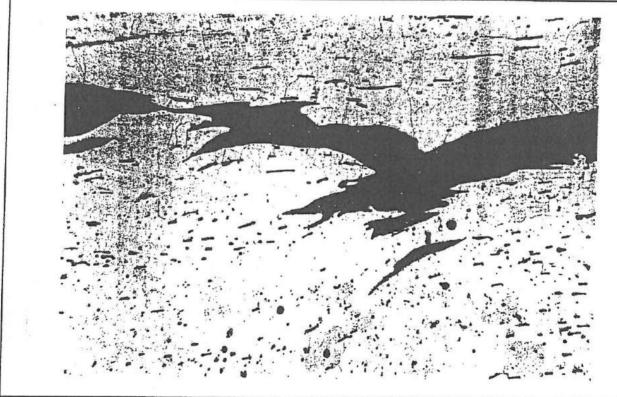
Plate No.: 2 Magnification: X100 Etchant: 2% Nital Grain Size Index: III

Met Lab Ref: ME479-2 Client/Ref Description: §" Plate

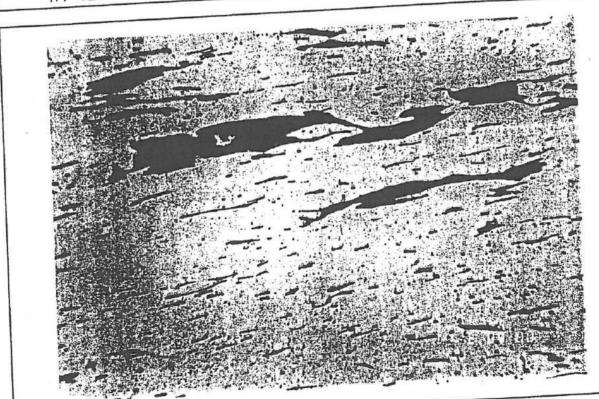
Metallographic examination of the five samples showed microstructures consisting of large non-uniform slag/oxide inclusions in a course ferritic matrix. The structures were highly variable and some of the inclusions were very large which makes these materials typical of a poor quality wrought iron.

Comments: Sample ME480-1 etched in 2% Nital showing a microstructure consisting of large nonuniform slag inclusions in a coarse ferritic matrix typical of a poor quality wrought iron.

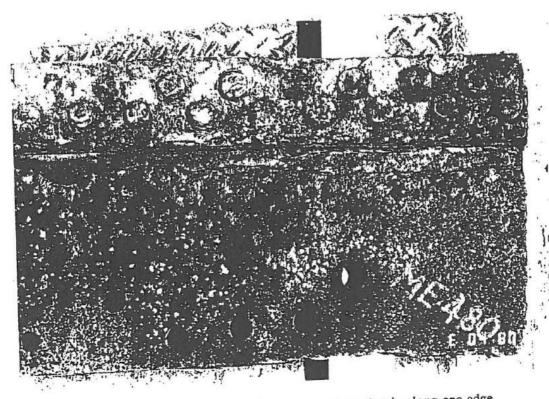
Plate No.10 Showing sample ME 480, as received, with the rivetted strip along one edge.

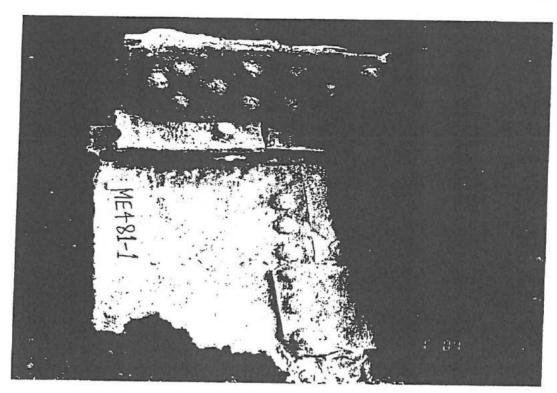
Plate No.11 Showing sample ME 481 a compound rivetted section with plate and angle sections, as received at the Laboratory.

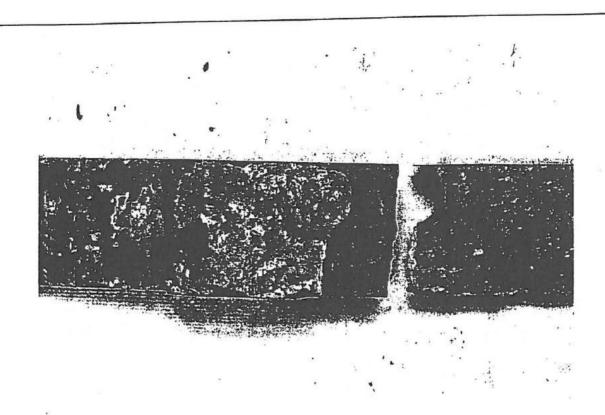
Plate No.12 Showing a tensile test specimen taken across the rivetted joint after testing. This shows the sample failing by tearing of the parent plate around the rivets rather than due to shearing of the rivets.

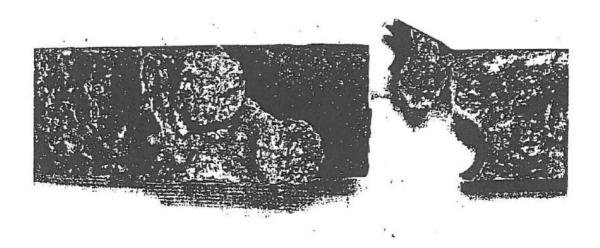
Plate No.13 Showing a tensile test specimen taken across the rivetted joint after testing. This shows the sample failing by tearing of the parent plate around the rivets rather than due to shearing of the rivets.

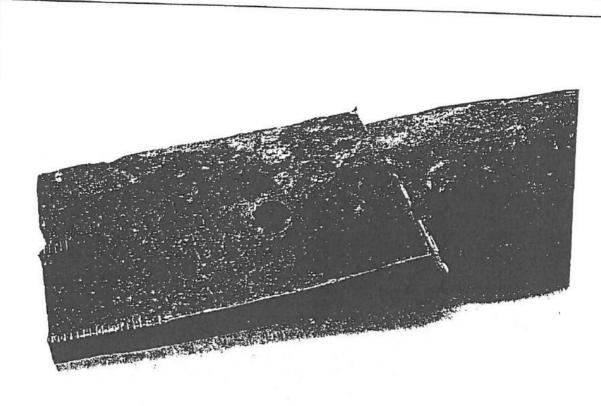
The third tensile sample failed by the plate material pulling over the corroded head of the rivet see Plate No.14. This occurred due to the extensive loss of section by corrosion which had completely removed the head of the rivet.

Plate No.14 Showing a shear test on a rivetted sample carried out in tension. This sample failed by the plate pulling over the badly corroded head of the rivet.

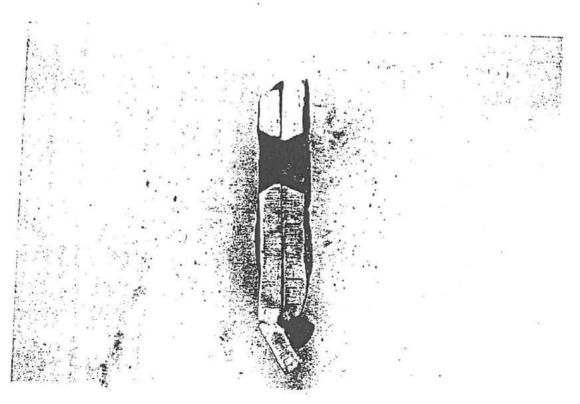
Plate No.15 Showing a shear test sample, in compression, where failure has occurred due to fracture of the parent material outside of the rivetted joint due to the large loss of section in this area.

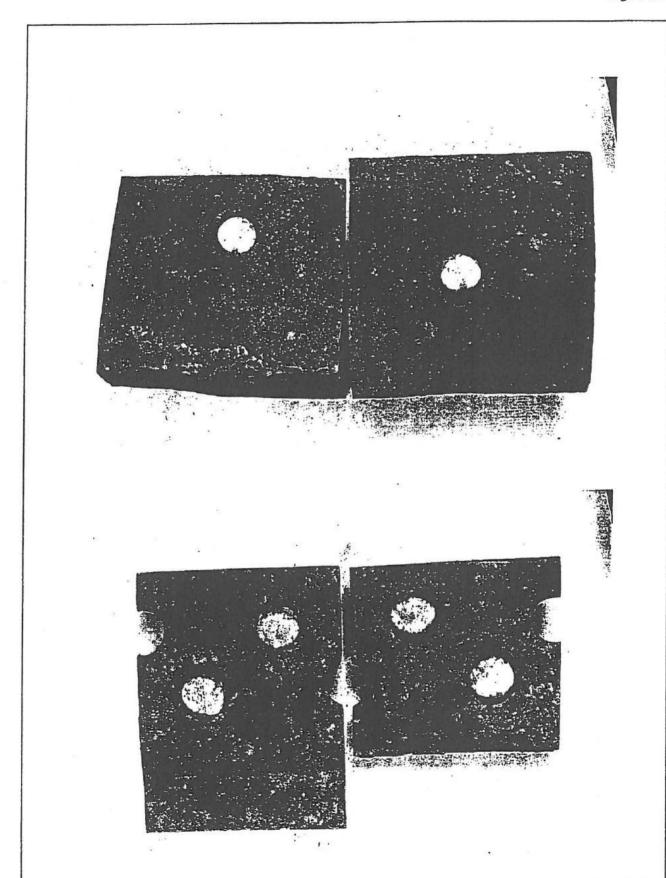
Plate Nos.16 and 17

Showing the shear mode failure of two of the samples tested in compression. Both samples contained 1" rivets which failed with typical fracture faces and distortion in the holes in the plate.

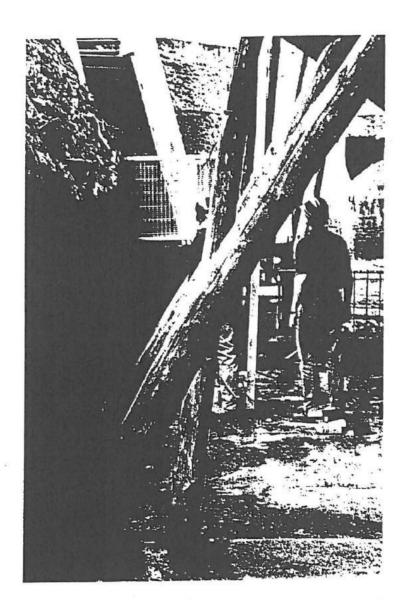
Plate No.18 Showing a view looking forward on the starboard side of the ship. This shows the distortion in the angled props where they are locked in against the side wall of the dock.
