David Watkinson, Matthew Tanner, Robert Turner and Mark Lewis

ss Great Britain: teamwork as a platform for innovative conservation

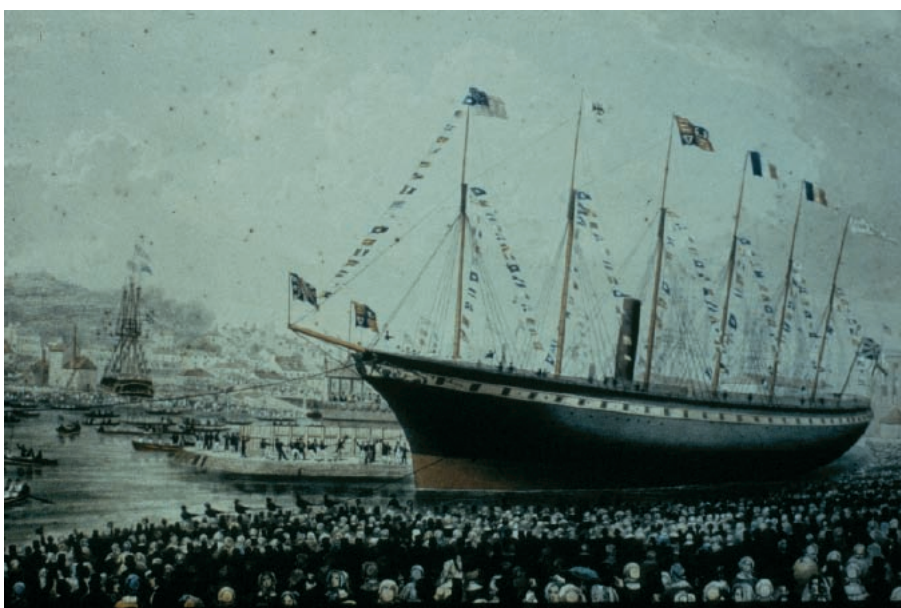
Fig 1 ss Great Britain at her launch in 1843.

with a wrought iron hull and screw propulsion, she was then the biggest ship in the world at 322 feet long (see figure 1).

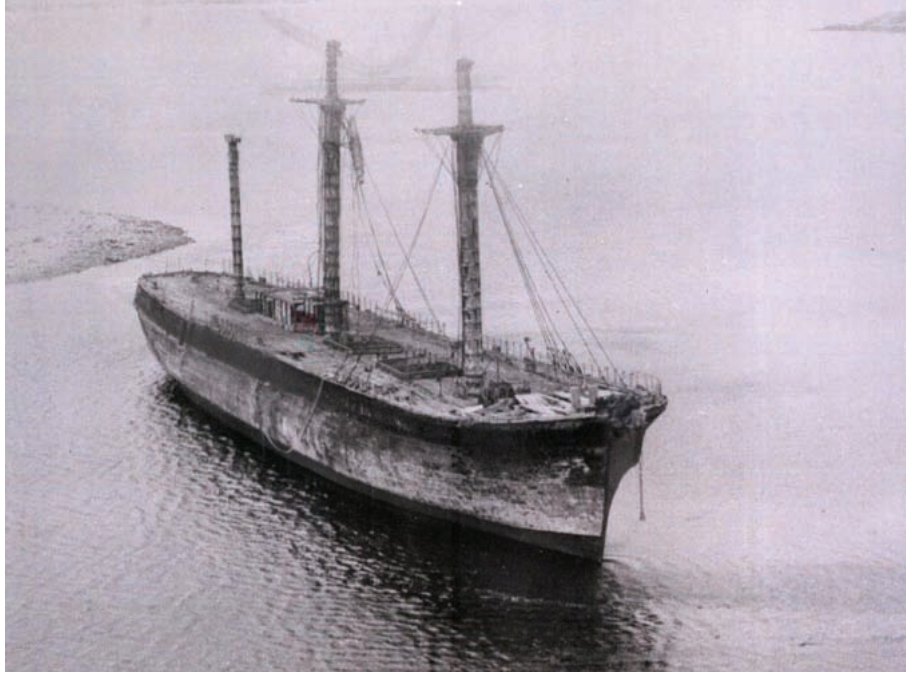
Figure 2 ss Great Britain sitting in Sparrow Cove.

After a short transatlantic career she was engaged in taking emigrants to Australia and in later life she was converted to a sailing ship, but after suffering damage rounding Cape Horn the ship was purchased by the Falkland Islands Company to serve as a floating warehouse (1887–1933). In 1937, once she became too old for this job she was towed to Sparrow Cove and holed to enable her to sit on the shallow bottom, where she was left to rot (see figure 2).

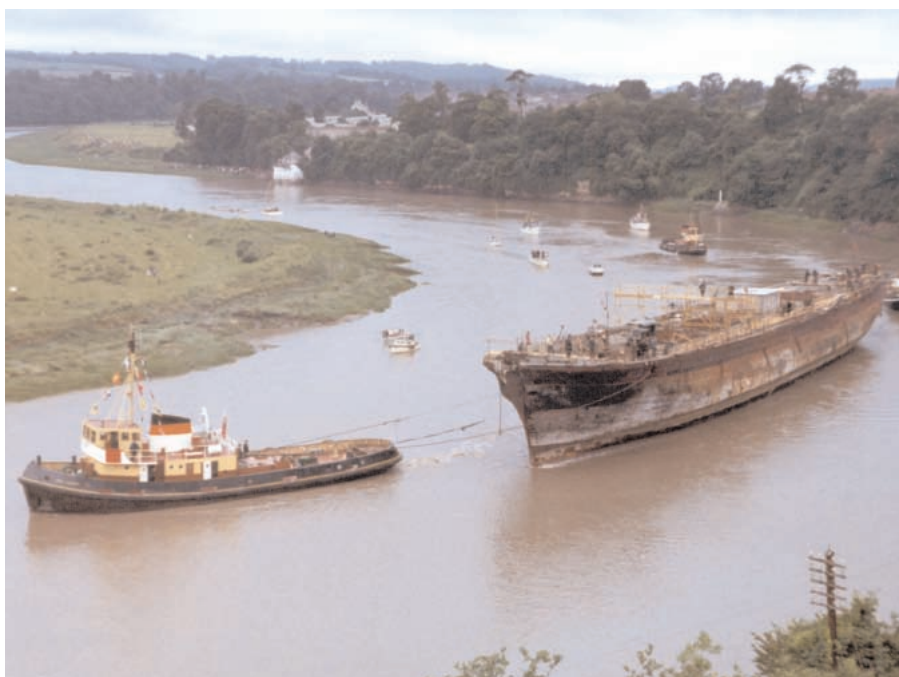
Figure 3 ss Great Britain travelling up the River Avon.

The ss Great Britain Project was created in 1968 to salvage the ship and in 1970 she was towed across the Atlantic on a pontoon barge. The large size of this barge required the ship to be floated the final few miles up the River Avon (see figure 3) to her resting place in the original dry dock in which she had been constructed (see figure 4). This fortuitous union of ship and dry dock, with the surrounding workshops and offices that had supported its construction, created a large heritage site of world importance. Both the importance of this combination and its potential symbiotic relationship for visitors was not recognised and developed until a much later date.

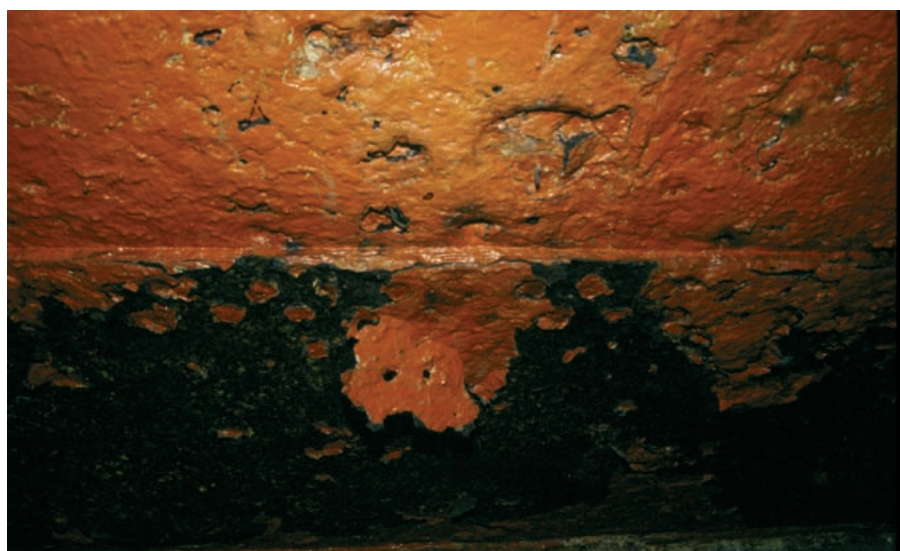
Figure 5 Corrosion at metallic anode sites and spalling of the corrosion product/paint layer.

Ferric oxyhydroxides (FeOOH), including Goethite (αFeOOH) and the chloride bearing Akaganeite (βFeOOH), were identified as corrosion products on the hull (Watkinson and Lewis 2004). Magnetite (Fe_3O_4) occurred at the less aerated metal/paint layer interface. Spalling of the corrosion layers revealed the metallic iron and a fresh $\text{FeOOH} / \text{Fe}_3\text{O}_4$ corrosion product mixture, often with weeping (see figure 5).

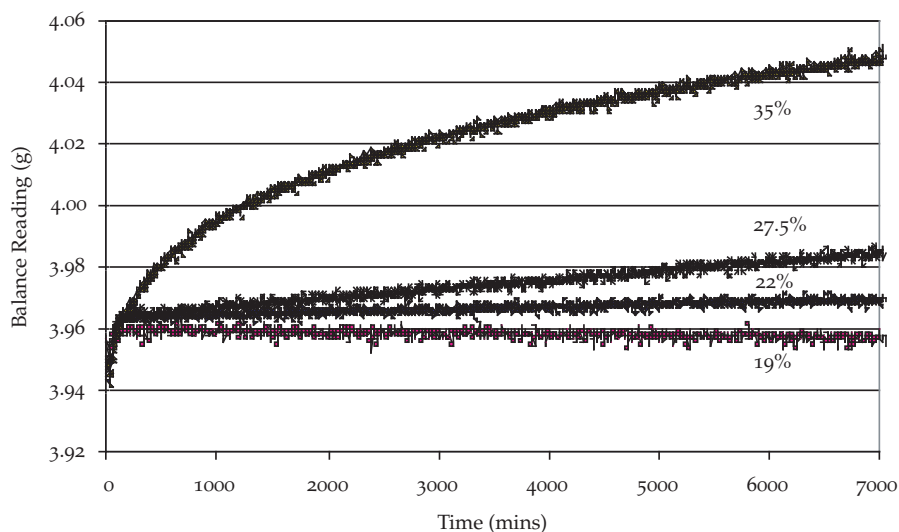
Figure 6 Weight change versus time for 2g iron powder and 2g ferrous chloride at selected relative humidities (Watkinson and Lewis 2004). $\text{FeCl}_2 \cdot 2\text{H}_2\text{O}$ at 19% and $\text{FeCl}_2 \cdot 4\text{H}_2\text{O}$ at other relative humidities.

$\text{FeCl}_2 \cdot 2\text{H}_2\text{O}$ was stable at 19% relative humidity and iron powder mixed with it did not corrode (see figure 6). In contrast $\text{FeCl}_2 \cdot 4\text{H}_2\text{O}$ was the stable hydrate at 22% relative humidity, where corrosion of iron powder occurred and became faster with increasing relative humidity (see figure 6).

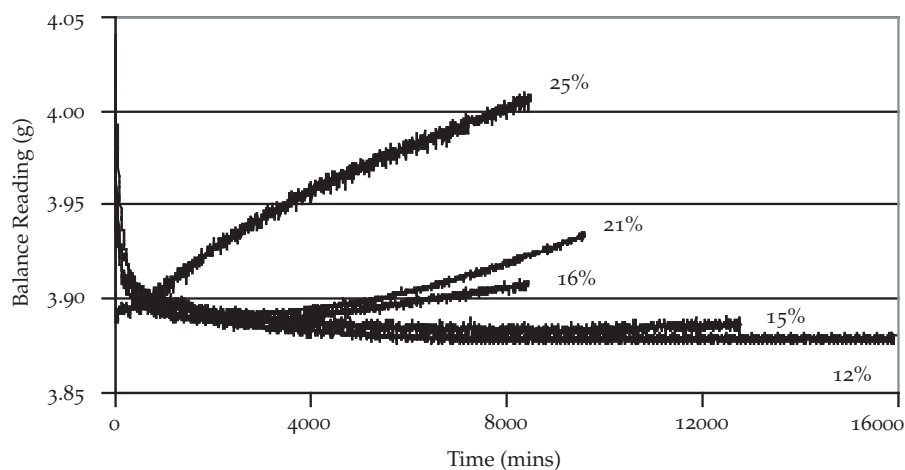
Figure 7 Weight change versus time for 2g iron powder and 2g beta-FeOOH at selected relative humidities (Watkinson and Lewis 2004). Initial weight drop is due to water loss from beta-FeOOH.

For mixtures of unwashed βFeOOH and iron powder exposed to various fixed relative humidity values, corrosion continued down to 15% relative humidity and was not measurable at 12% (see figure 7). Initial weight loss at low relative humidity is due to desiccation of the βFeOOH exceeding any weight gain due to corrosion. Later weight gain from corrosion exceeds any loss from desiccation.

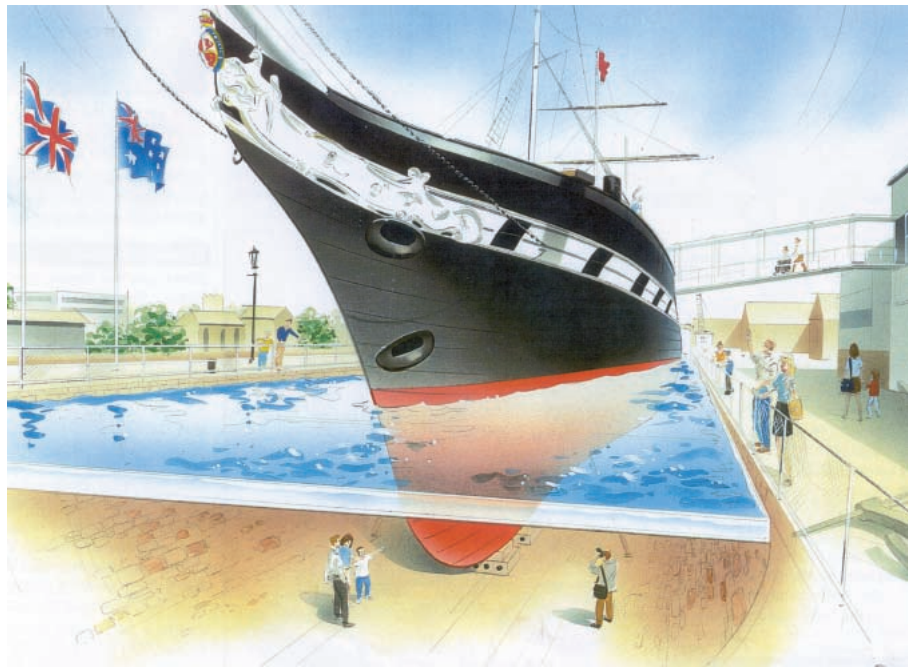
Figure 8 Artists impression of the controlled space around the lower hull of the ss Great Britain.

Cost and aesthetic considerations dictate the design of the controlled space around the hull. Similar criteria had influenced other designs for enclosing historic ships, where a national competition was used to find a design for the building to house the wooden warship *Wasa* (Hafors 1997). A structure to encase the whole of the ss *Great Britain* was rejected on the grounds of cost, major engineering issues and the aesthetic transformation of the heritage dock area. The solution adopted offers a visual concept of a floating ship with visitors able to explore below the waterline while inside the dry dock (figure 8). A glass water-covered horizontal plate constructed from the dockside to the side of the hull would enclose the chloride ridden lower section of the hull.

Within this space local drying of the hull will occur by dehydrated air channelled over its surface. Engineers and architects are responsible for designing plant and the new structure, taking into account operational parameters such as air leakage, solar gain, turbulence and temperature and moisture variation within the enclosed space. The interior of the ship is being refitted to represent various periods in the history of the vessel. The entire hull interior will form part of the controlled environment and will be sealed against the atmosphere. In this way science has been used to address the chemistry of corrosion and architects and engineers translate this into a control solution by overcoming the practicalities of environmental control.
