**Conservation Plan**  
for the  
**Great Western Steamship Company Dockyard**  
and  
**the *ss Great Britain***

January 1999

Reviewed & revised March 2007

Volume 1 prepared by  
Keystone  
in collaboration with  
the SS Great Britain Project

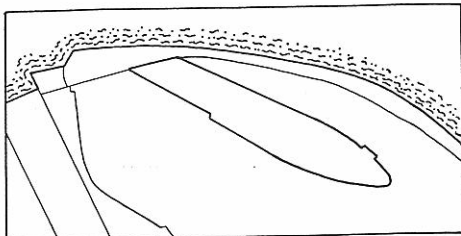
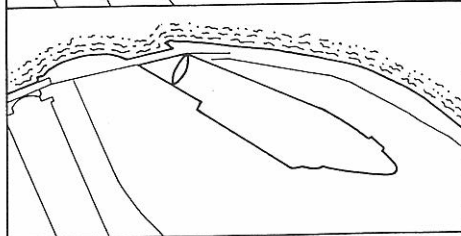
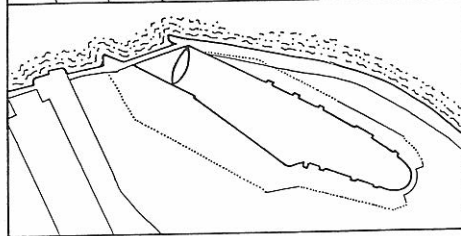
The kink on the south side does not appear on an 1855 map & is first shown on a map of 1870, BRO, 'Ashmead 1870'.

The blunter nose and extension of the dock to the east is shown on the 6" OS map of 1903, BRO, 210 (b)

[10] The evolution of the dock shown graphically. This sequence is based on historic maps & plans, re-drawn to the same scale by Rupert Ford and Sophie Sharif. Buildings have been omitted.

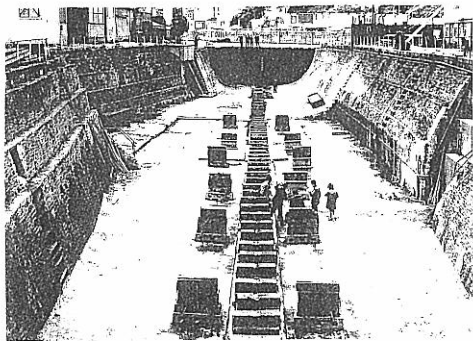
[11] *The dock in 1970, prepared for the arrival of the ss Great Britain. The first phase cradle-shaped profile can be seen clearly at the west end.*  
© Richard Goold-Adams.

*The dock was built by the GWSSC in 1839 with advice from I K Brunel. The existing dock, includes evidence for at least three or four major historic building phases, with later phases of post-war concrete repair and alteration. Originally cradle-shaped, a kink was added in the south side of the dock at some time between 1855-1872, probably for William Patterson. At the same time, or maybe later, the east end was rebuilt for a flat floor and finally, in c.1903, soon after the dock had been taken over by Bristol City Council, the east end was extended a short distance [10].*

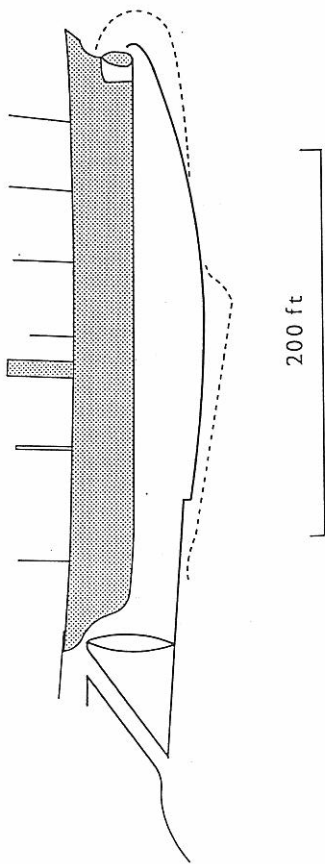
[12] Scale drawing by Rupert Ford, adapted from Corlett, 1971, 17, showing the tight fit between the first phase of the dock and the ship. Later extensions to the dock are shown as a dotted line.

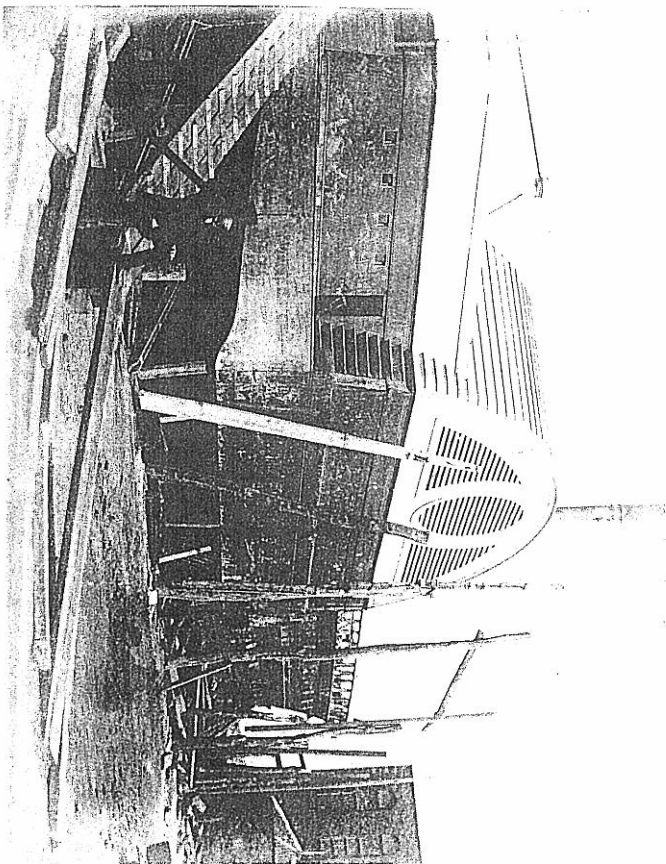
[13] The south side of the dock shown in a photograph dated to between 1853 & 1855, when William Patterson was working on the 'Demarara' in the dock. Surviving cut-down timber posts may be the remnants of the scaffolding shown here. The round building may have been a resonometer. V&A, Ph. 56-1983. © V&A Picture Library.

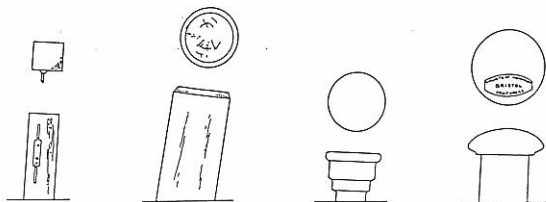
[15] A selection of the designs of iron bollards and timber posts round the dock, drawn by Rupert Ford.

These might be considered to be listed Grade II\* as part of the curtilage of the dock. The dock is surrounded by a variety of bollards of different designs, both timber and iron [15]. Timber posts, noted on Ordnance Survey maps as 'MP', for mooring posts, are part of a very closely-spaced series that may originally have been taller posts used as scaffolding for construction work in the dock, cut down to bollard size later. An arrangement of posts is shown in the important pre 1855 photograph of the south side of the dock, when the *Demerara* was being worked on by Patterson (V&A, Ph. 56-1983). Bollards marked on the 1885 OS map, extend round the kink and (unextended) east end of the dock and also appear (some possibly being cut-down scaffolding posts), in late 19th century photographs (BIM, Keen, 15/57, dated by Andy King of BIM as pre 1898; BIM J127 [18]).

There are two types. The earliest are c.1900 cast steel; the second set are c.1930 cast iron from a traditional pattern.

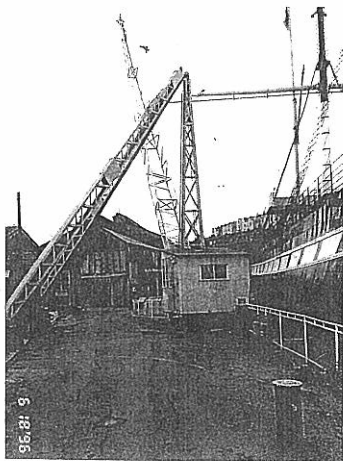
[16] Scotch derrick on the S side of the dock.

A Scotch derrick is shown on a 1920 plan (Bristol RO, 32173/839) but just west of the kink, not east, as the present crane is. The present crane has an insurance document dated 1923 [16]. A crane was still in this position in 1930 (plan accompanying agreement of 31 December 1930, Tucketts). It is not clear when the crane was moved/replaced. It is not shown on Goad's Fire Insurance plan (perhaps omitted because it was machinery) of 1945, probably revised 1952 (date of copyright on plan, BRO, 35033/2). Sheer legs are shown on a pre 1895 photograph of the dock (BIM, Keen 22/147). A c.1960 photograph shows a second Scotch derrick on the south side of the dock (SSGB, Aerofilms, C6873).

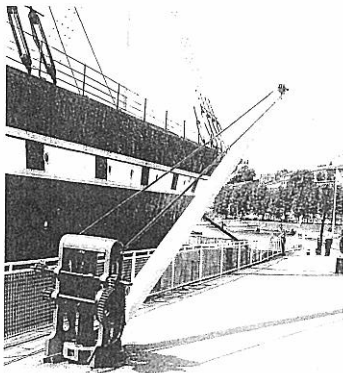
[17] One of the hand derricks on the N side of the dock.

2 smaller hand derricks on the north side of the dock were *in situ* by 1970 [17].

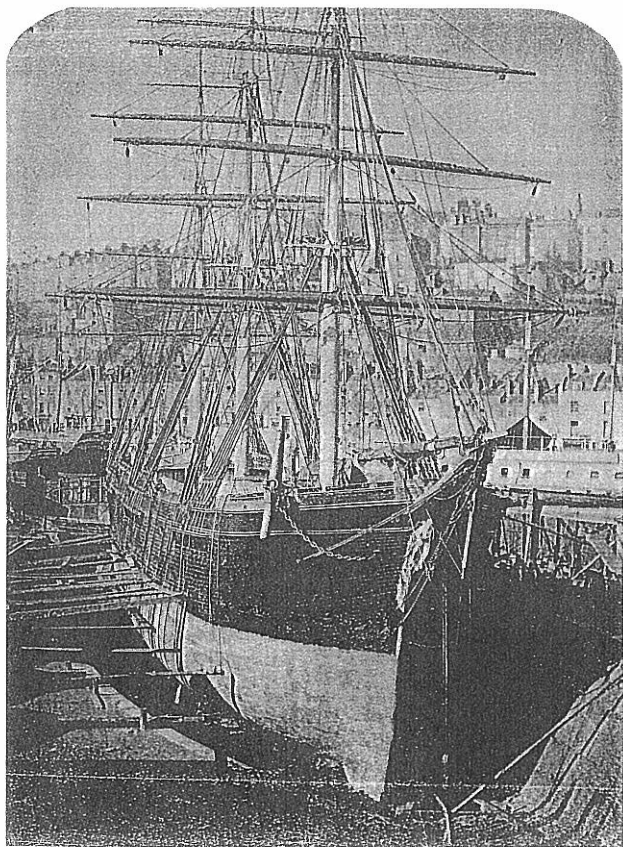
[18] *The dock in a photograph of the c.1880s. This shows the kink; posts (possibly cut-down scaffolding posts) along the southern side and the south edge of the dock before BCC bought the dock in 1902 and extended it, BIM, J127. © Bristol Industrial Museum*

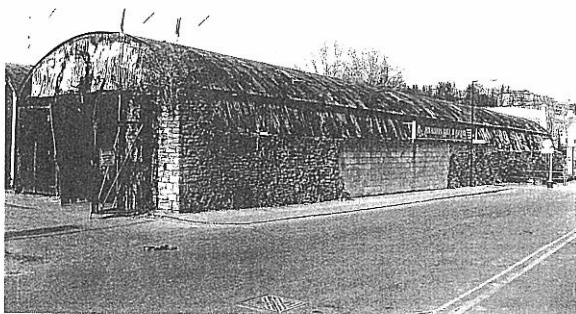
[21] *The remnant walling (east side & south end) of the factory as surviving in 1998.*

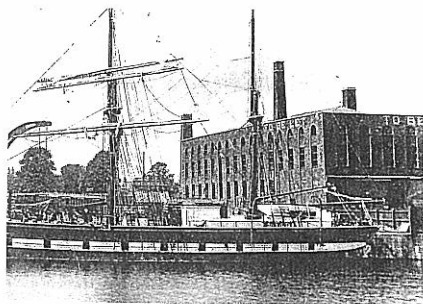
[22] *The east side & north end of the factory in an extract from a c.1900 photograph, BIM, York 4424. © Bristol Industrial Museum*

The range aligned north/south was built, like the dock, of Pennant stone. It was 3 storeys with a triple roof and 16 bays long x 8 bays wide [22]. The second floor windows were round-headed, with square-headed windows to the first floor. The west/east range is something of a mystery. The cartographic

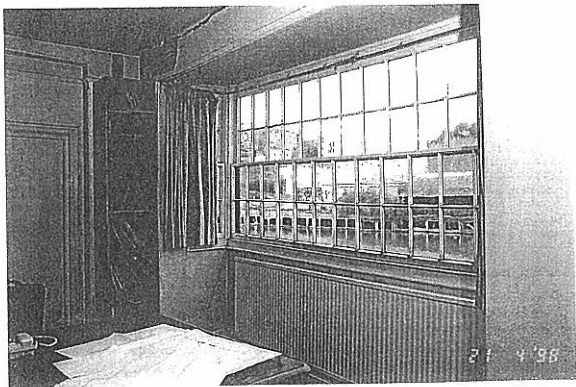
[30] Stylistic evidence - the small panes of the oriel window and the joinery in the office suggests a date of c. 1840

The stylistic evidence, however, suggests that such a late date, i.e. after 1846, would be surprising [30]. It also raises the question of where the GWSSC dock office was, and why it did not survive. There must have been a dock office and the present building is ideally sited for one. In short, the answer to the question of whether this is the GWSSC office or one built for Patterson depends on whether you believe the Ashmead cartographic record or put your faith in an analysis of the style of the building detail. Historic maps do have variable accuracy and survey updates can predate the date of publication. On balance it is the opinion of Keystone Historic Buildings Consultants that the office is GWSSC period<sup>9</sup>.

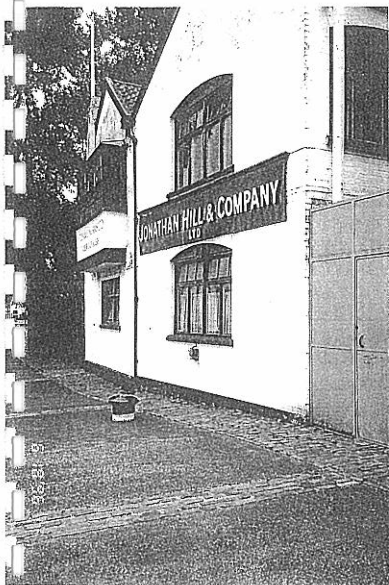
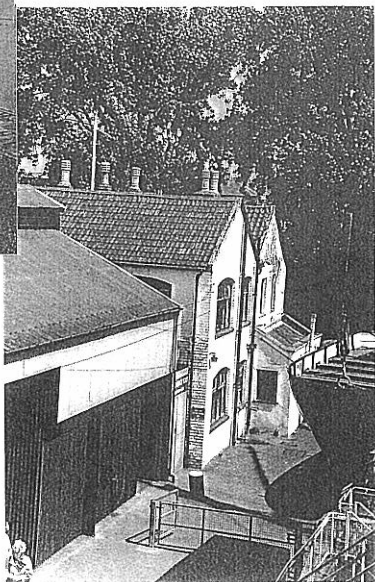
31] The dock office from the towpath  
(N elevation) and to rear (S) from inside  
the dockyard in 1998.

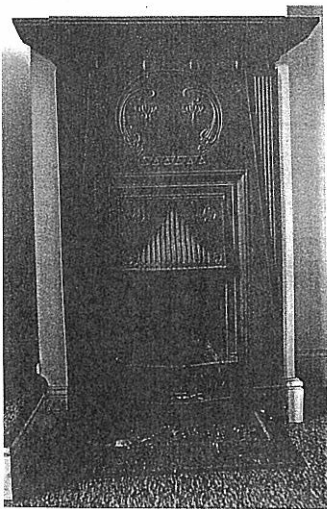
[32] One of the c.1905 chimneypieces.

The first floor was less affected by this refurbishment although the middle and southern offices acquired new chimneypieces in Art Nouveau style.

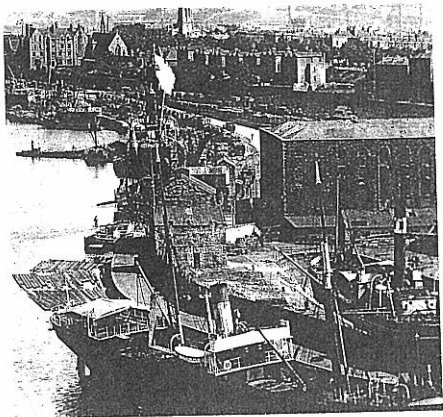
[33] *The east block of the dock office in c.1917, after the adjacent buildings had been demolished. The 3 chimney shafts are clearly visible, BIM, York 3309. © Bristol Industrial Museum.*
