4 - Understanding the Ship

Part Two: The ss *Great Britain*

4.1 - The Great Western Steamship Company Period

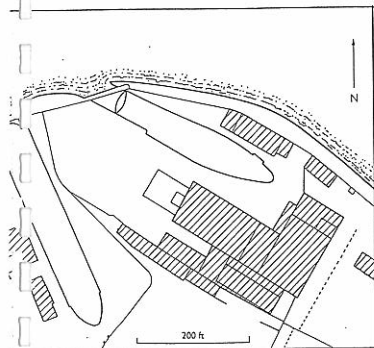
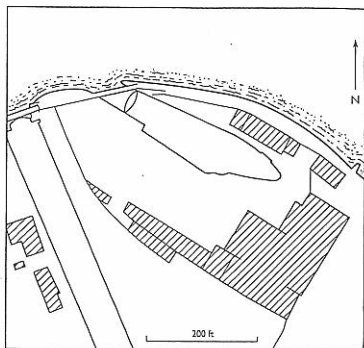
[44] The S boundary wall in 1855 and after the 1872 boundary change. Based on BRO 40860/65, 66 & BRO 37075/32, redrawn to the same scale by Rupert Ford

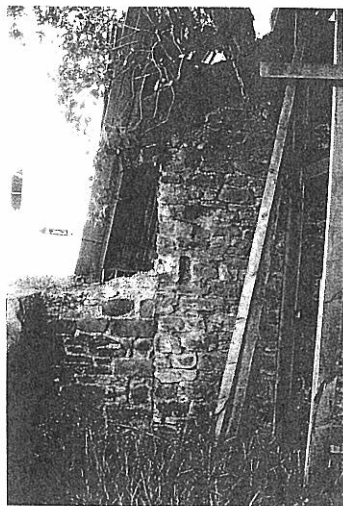
[45] Walling, possibly 1840s, projecting off the S boundary masonry wall & containing a blocked stone arch.

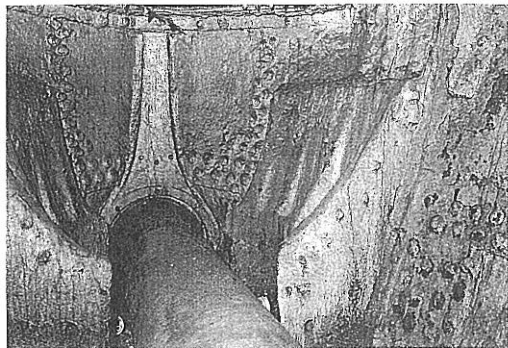
[53] *Surviving detail from the first phase. The stuffing box, a substantial iron casting where the screw shaft entered the stern of the ship.*

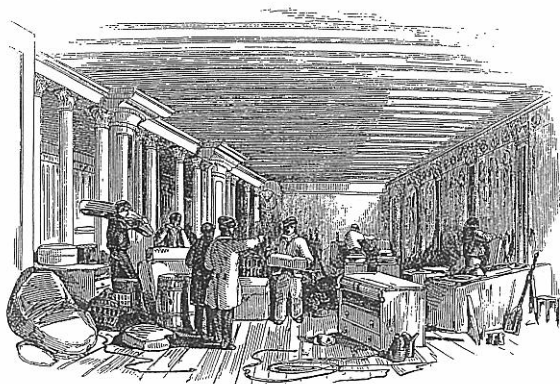
[61] *The removal of the stores from the state cabin, ILN, 24 October 1846.*

Internal fittings had to be stripped out to lighten her [61]. It may be, that without this accident, the company would have survived the objections of their shareholders and hung on to their iron steamship factory, developing into a marine engineering outfit as well as a shipping line. After risks at every turn in the undertaking, it was a miserable thing that a simple navigational error should close the book on the company, which was compelled to drag out an existence until 1852 when its assets were finally disposed of.

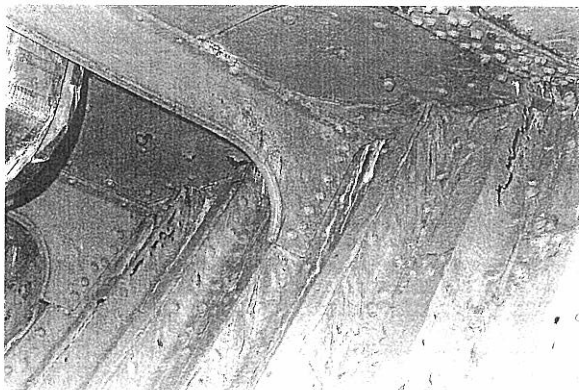
[80] A Butterley beam in situ, fixed to a Phase One angle iron frame.

Butterley beams, sometimes known as a 'tee bulb' were patented by Mr Alleyne in 1859 and recommended for the support of wooden decks in Reed's *Shipbuilding in Iron and Steel* (1869, 139) and Thearle's *The Modern Practice of Shipbuilding in Iron and Steel* (1886, 49-51). The T part of the beam and the bulb part were rolled separately and welded together along the neutral axis of the beam. After 1869 the form of bulb-iron in general use for deck beams was rolled in one piece, with angle irons riveted on either side of the top edge after the round-up had been performed. This is similar in appearance to the tripartite 1866 beams which support the present upper deck. The Butterley Beams are noted as 'patent tee bulbs' in the 1882 cross section of the ship. The ship was ceiled with widely-spaced planking in the cargo areas.

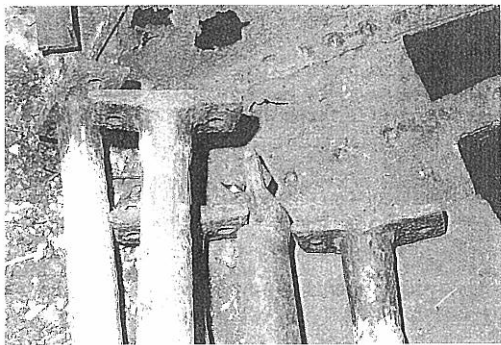
[81] Loose stanchions in the ship in 1998 clearly show the design of the stanchion base (although there are variations to the stanchions in situ) and the curved lapped design of the top which curves over the bulb to support the Butterley beams.
