Conservation Plan  
for the  
Great Western Steamship Company Dockyard  
and the  
*ss Great Britain*

Volume 2 - Condition Report and  
Recommendations for the *ss Great Britain*

Prepared by Eura Conservation Ltd  
and the *ss Great Britain* Project

December 1999

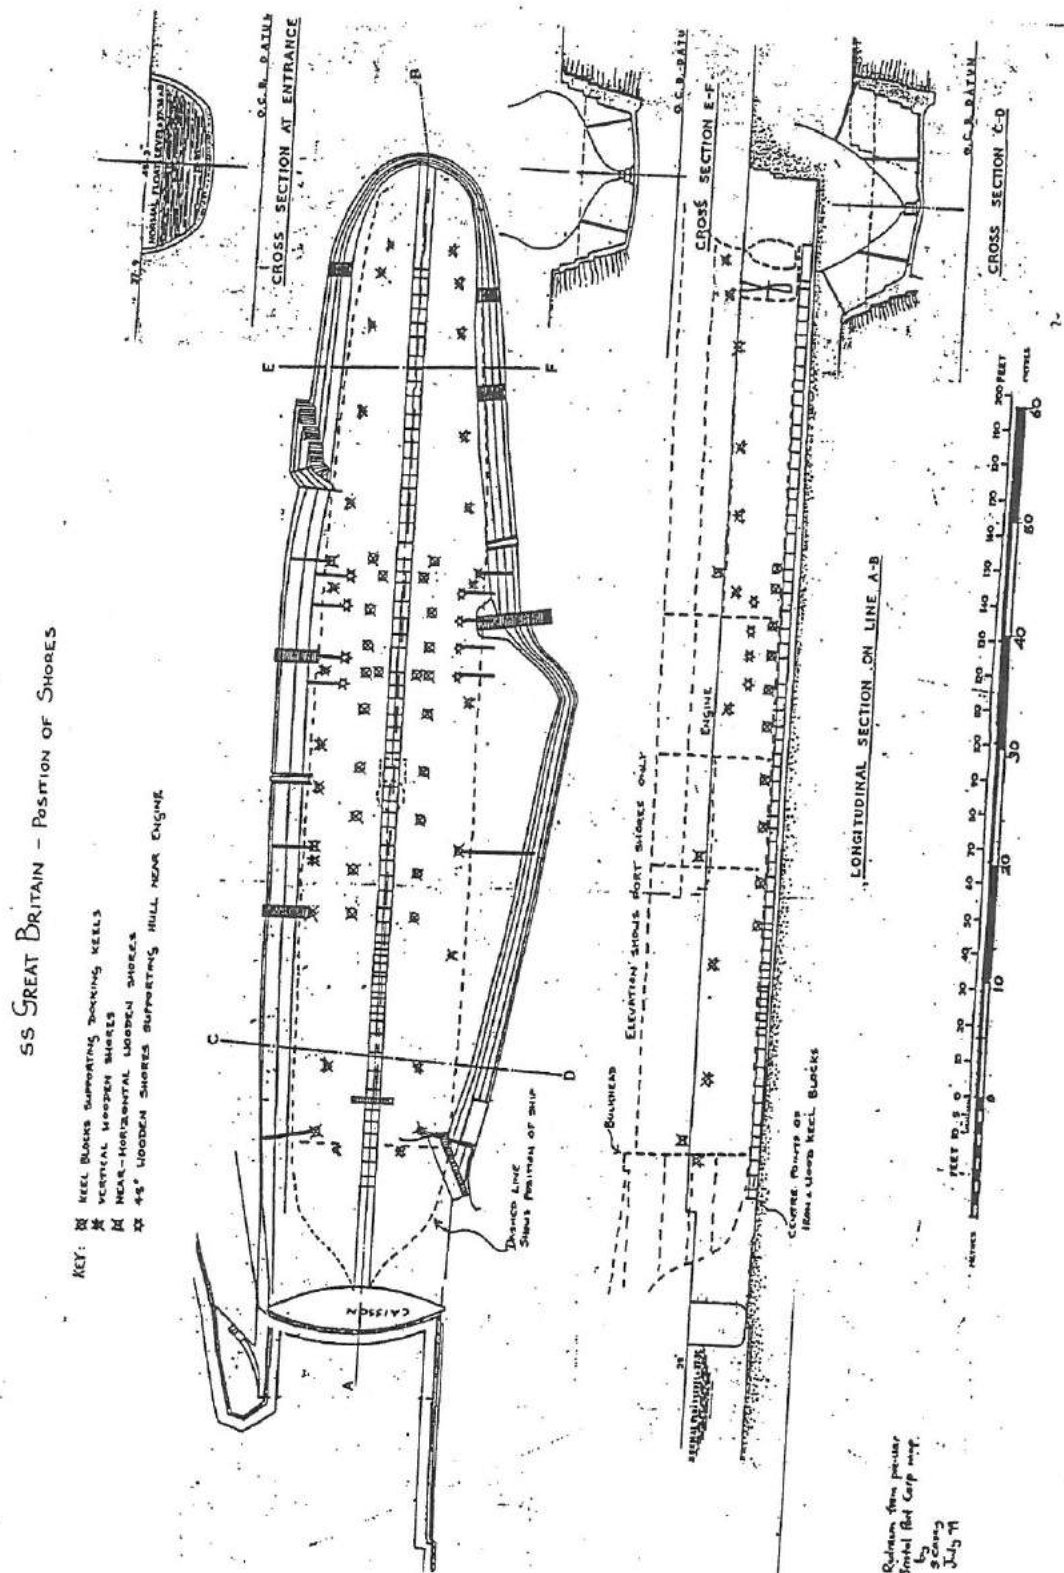
Figure 11 Plan of the Great Western dry dock showing the position of the external ship supports

- 9.46. The ship is supported on a series of 73 keel blocks and 33 shores (see Figure 11). The shores are of variable quality and carry varying loads. Some are bent, presumably because of the increase in loads they are carrying and a number have obvious wet rot.
