SS GREAT BRITAIN DECK DRAINS - PRESENT AND FUTURE

Report on leaks into the ss Great Britain's Promenade deck from the weather deck -
Shane Casey, 1999

SS Great Britain - Report on Water Leaks

ss Great Britain - Condition Survey Soluble Chloride Contamination

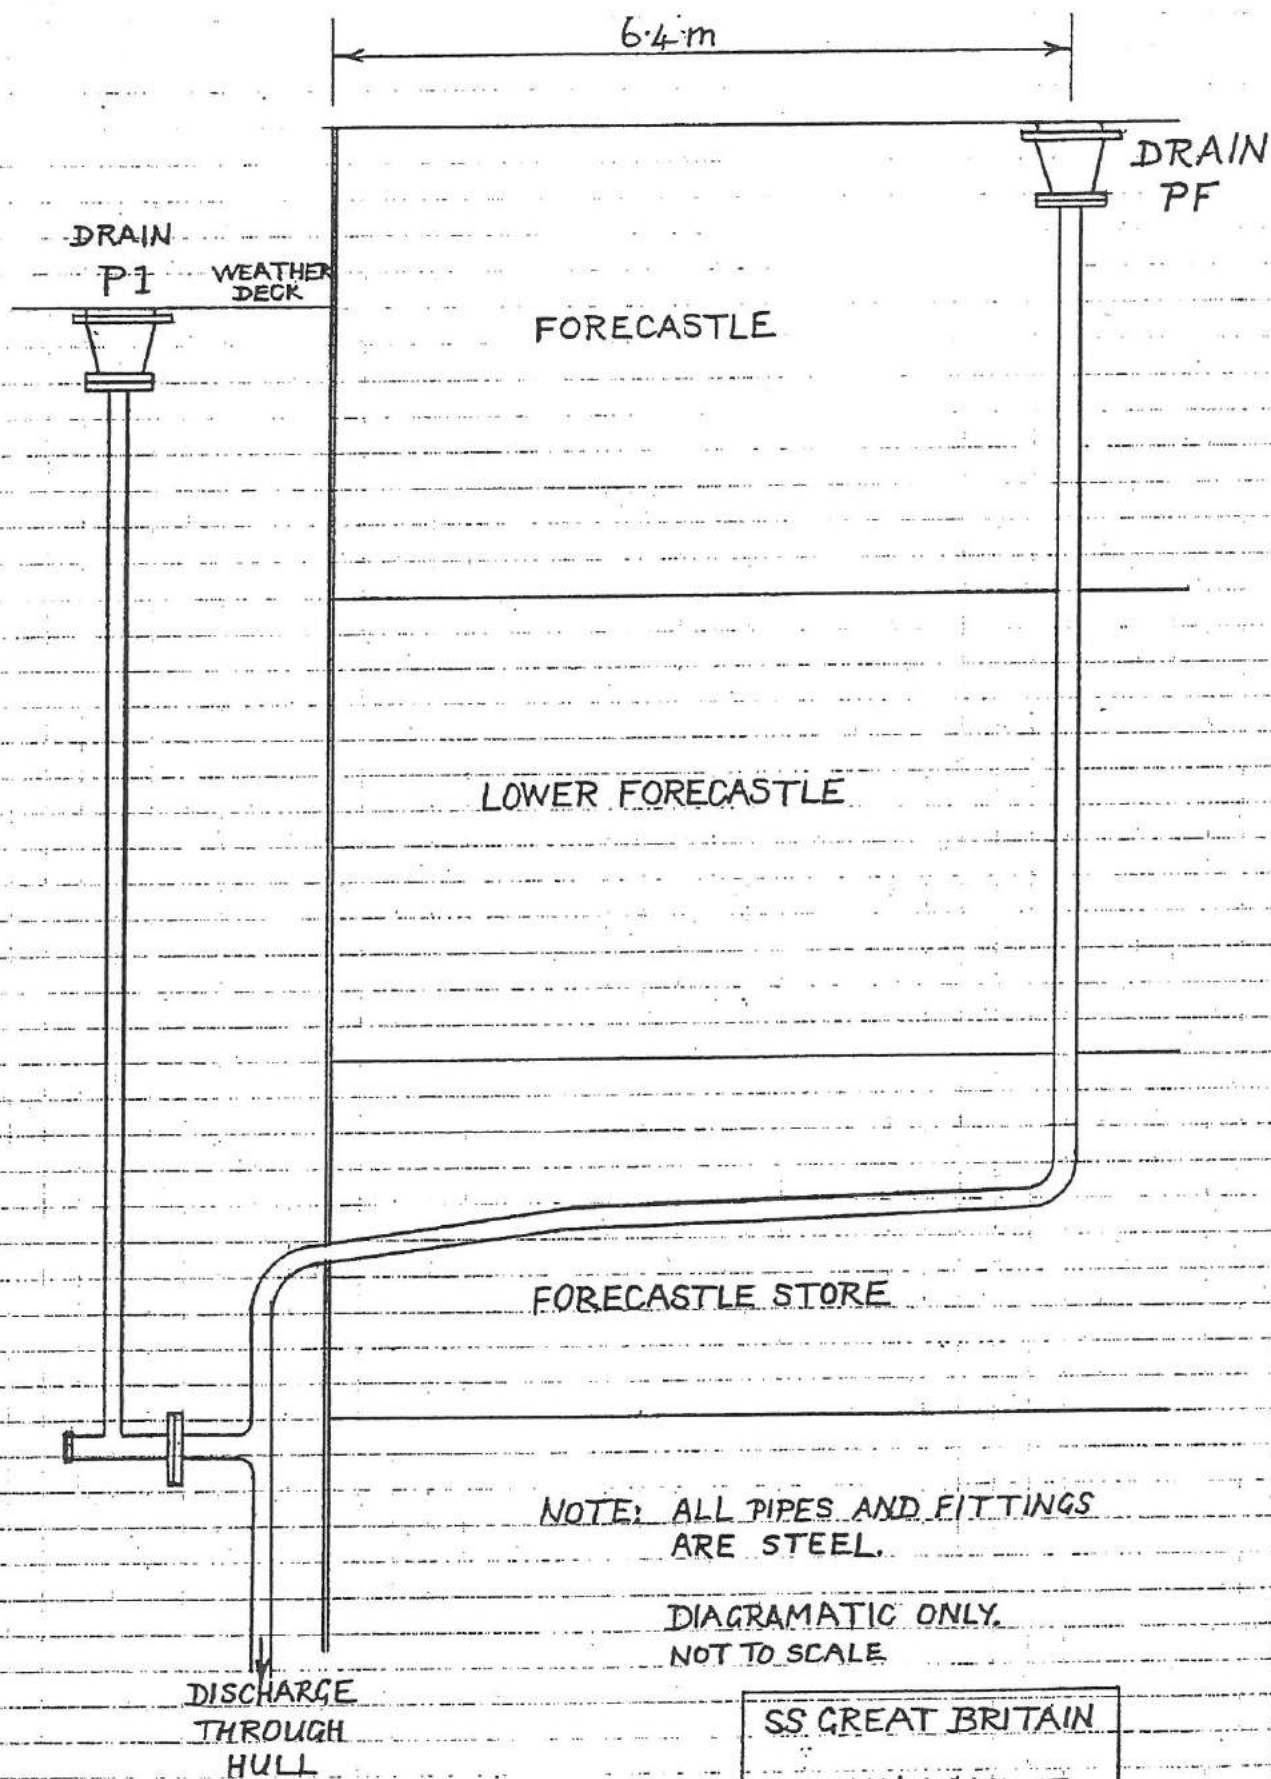
DRAIN LAYOUT
PORT SIDE (PART)

- 3.6 The forward (concrete) section of the forecastle deck requires its own drainage as it is lower than the planked section. There are at present pipes port and starboard which collect the water but these pipes are cut off about 150mm below the steel deck. This is clearly not satisfactory. It may be better to try to channel the water under the planked area.

- 3.1 Lift loose margin boards and modify to make them easily removeable.
- 3.2 Establish a maintenance routine to check and clean the deck drainage grids and clear any accumulation of rubbish at the deck margins.

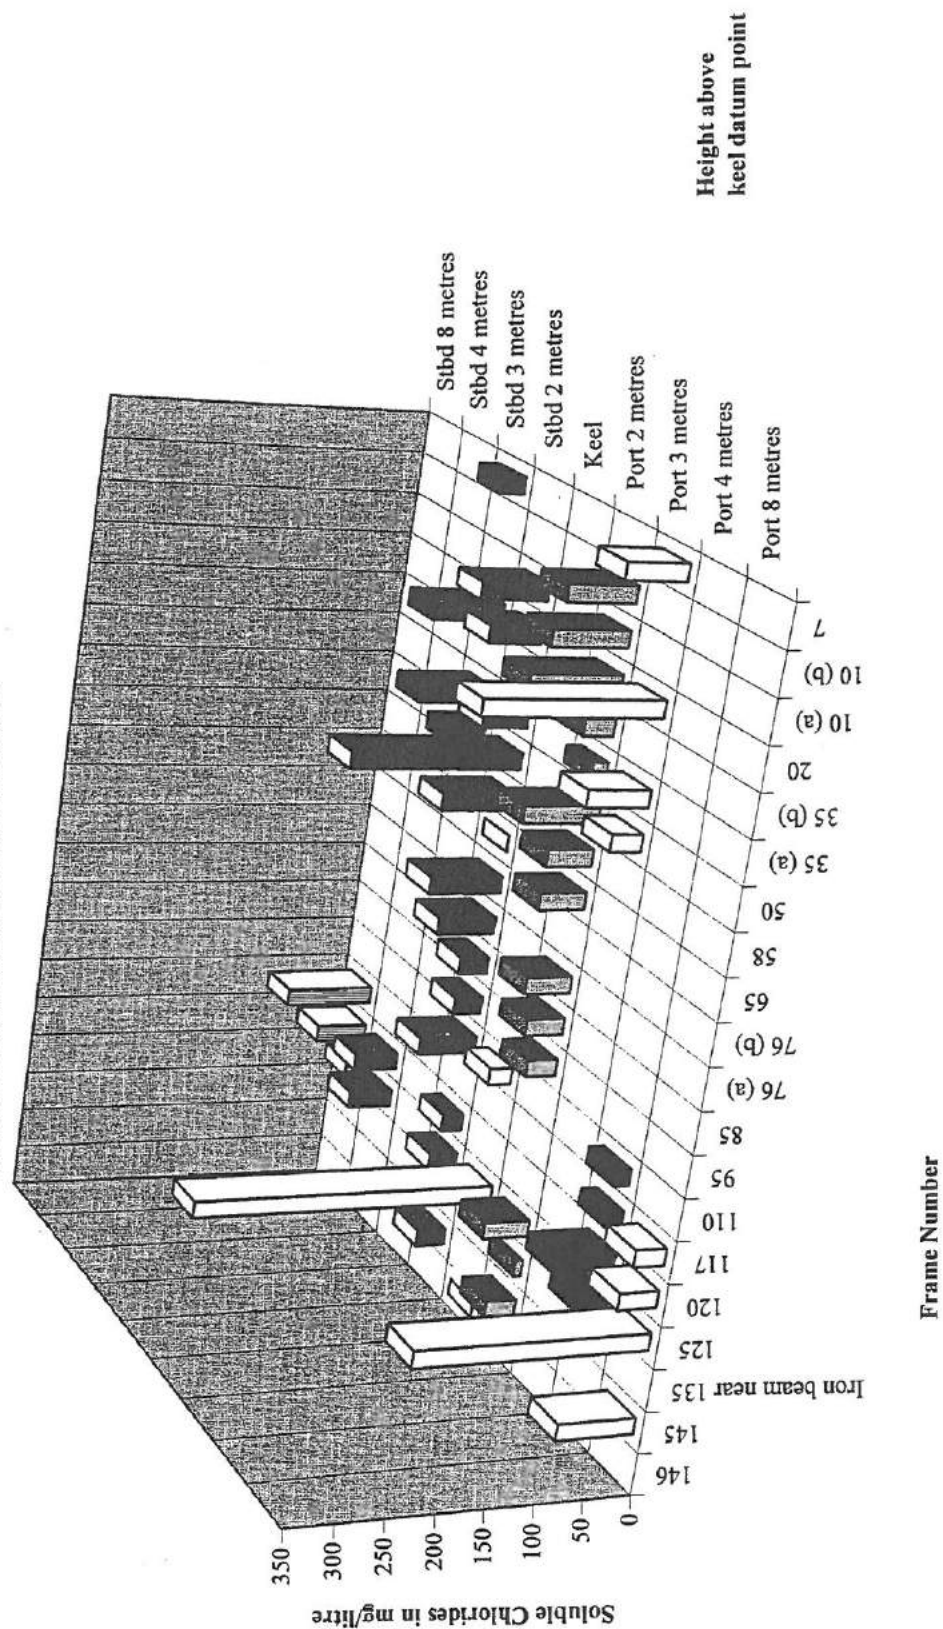
Soluble chloride levels are being measured on 2, 3, 4, 6, and 8 metre waterline intervals throughout the hull, measured from a datum on the keel near the mainmast. Where the same frame is shown as (a) and (b), two independent tests were made.

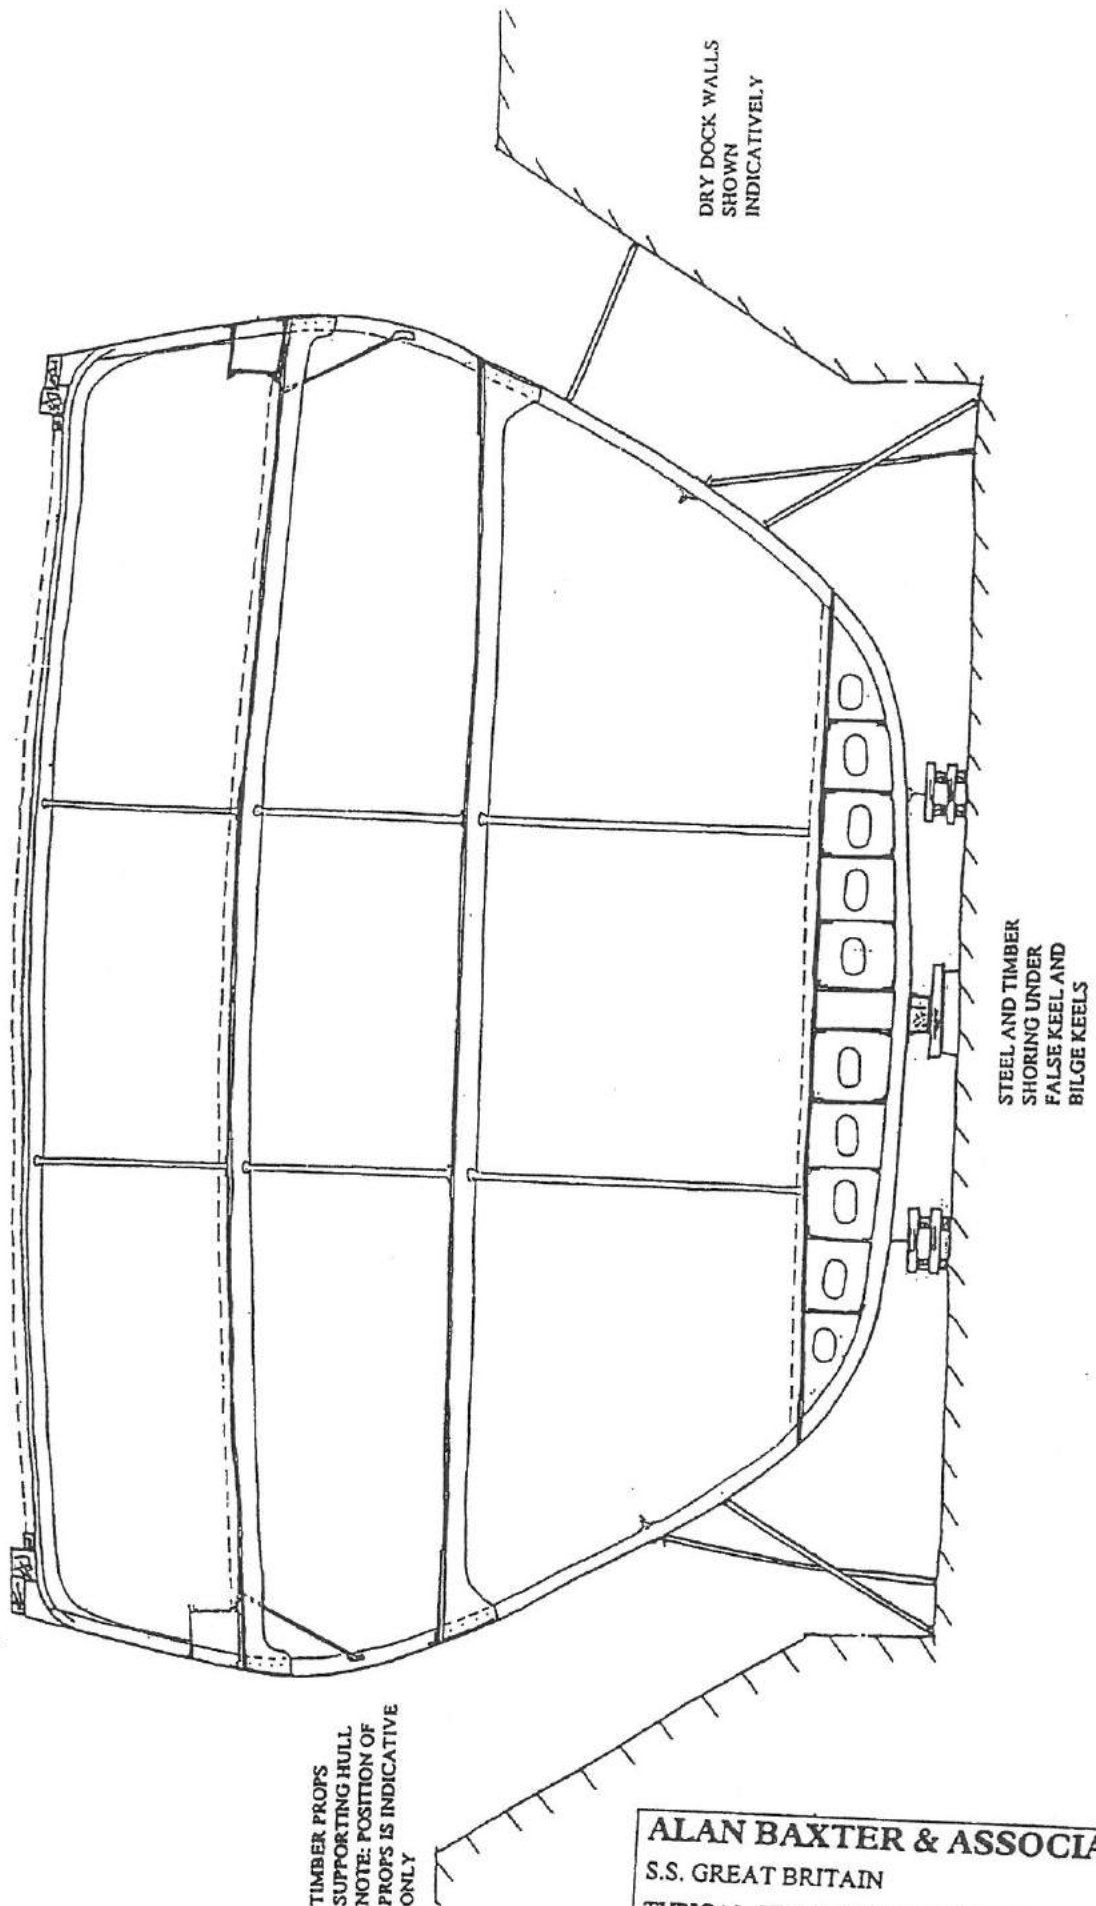
FIGURE 4

For an iron ship to have spent almost 100 years afloat and 34 years scuttled is quite remarkable. But despite the inherent robustness of the original design and material the ship is now delicate and its future must be out of the water. However the load conditions of the ship in dry dock are quite different from when the ship was afloat (Fig. 4). In dry dock:

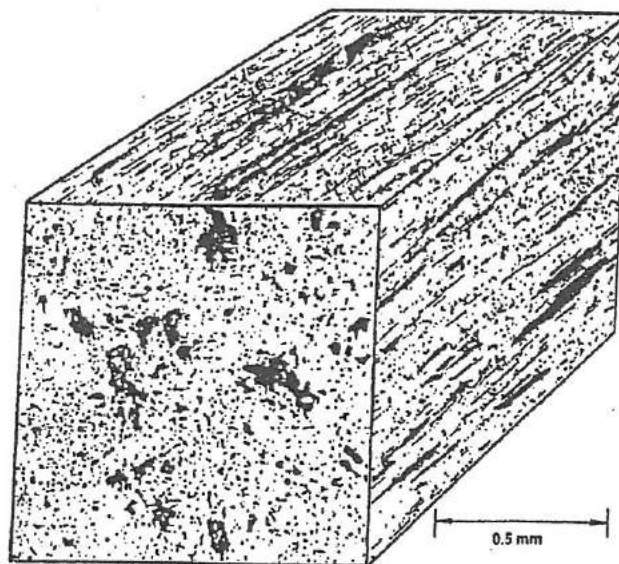
Fig. 1

From all the components listed above, orthogonal metallographic sections were prepared in order to examine the microstructure of the wrought iron. All the components examined exhibited very similar structures comprising a three dimensional polygonal ferritic grain structure, heavily interspersed with slag fibres which had been elongated in the direction of final working of the components during manufacture. A three-dimensional composite micrograph of the observed structures, (after light etching), typically representative of all the components examined, is shown in Fig 1.

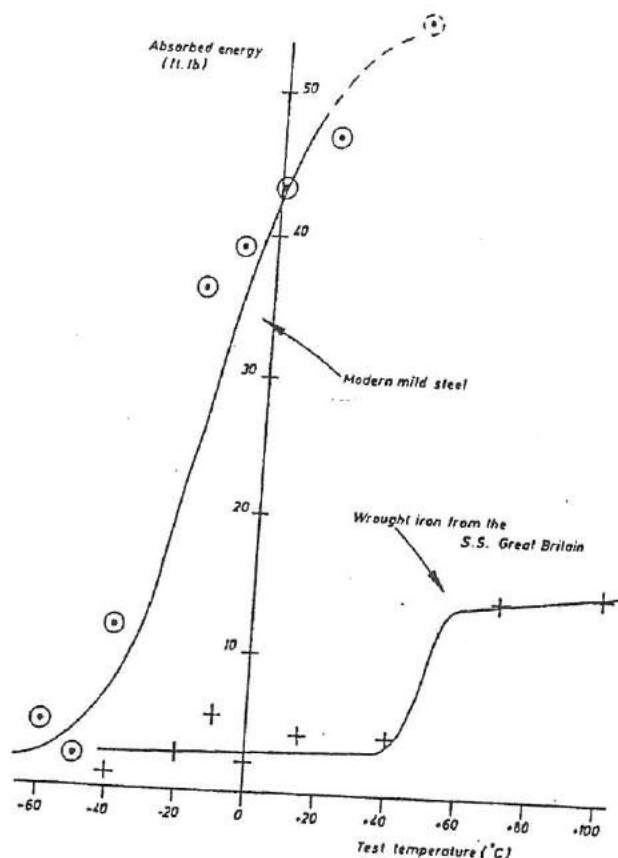
Fig. 2

The notched impact results for the components from the S.S. *Great Britain* (and for comparative purposes, those obtained from modern mild steel specimens) are shown in Fig 2. In this figure, the vertical axis identifies the amount of energy used to break the specimen, while the horizontal axis indicates the test temperature. The S shaped curve obtained for the modern mild steel specimens is exactly as expected.

This curve shows that mild steel is tough at normal working temperatures (~ +20°C) and at these temperatures can absorb very high impact energies before fracturing. As the temperature drops, however, say to -60°C, even modern mild steel becomes brittle and susceptible to fast fracture. The average temperature at which the transition from ductile to brittle behaviour occurs is known as the ductile-brittle transition temperature, which for mild steel is seen to be somewhere around -20°C. For the wrought iron of the S.S. *Great Britain*, however, the results are very different from those for mild steel.

Certainly the results show "upper shell" and "lower shell" values and also an identifiable transition temperature. However, even the upper shell values are below 20 ft.-lb, still relatively brittle, while the transition temperature is around about +40°C, well above the typical operating temperatures of the *S.S. Great Britain*. For a typical operating temperature of around +20°C it is seen that wrought iron is as brittle as mild steel is at -60°C, in other words, very brittle indeed and as a result, extremely susceptible to fracture resulting from sudden impact.

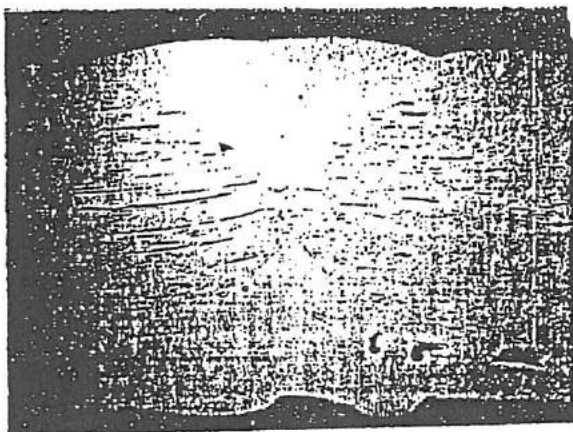
Fig. 3

Recent experiments have been carried out where a 1" diameter, 19th Century wrought iron bar was MIG welded using a mild steel filler rod and an argon shield. The two ends of the bar to be joined, were first machined to a point so that the weld metal would theoretically attach itself to all the exposed iron layers. After sectioning, polishing and lightly etching the welded bar, the new weld metal can clearly be identified, and although some non joining is evident in the centre of the weld, much of the rest of the weld seems to have fused into the original wrought iron with no obvious voids or lines of weakness.(Fig. 3).

The bar seen in Fig 3. was subsequently machined into tensile specimens which were each tested in the normal way. Not surprisingly, the specimen from the centre of the bar, where some segregation had been previously seen, broke at a low stress in the welded region. Of the remaining two specimens, however, where the weld looked sound, one broke in the gauge length, initiated at a large slag inclusion, (Fig. 5) while the other, surprisingly, broke once again with a low stress at the weld interface (Fig. 6).

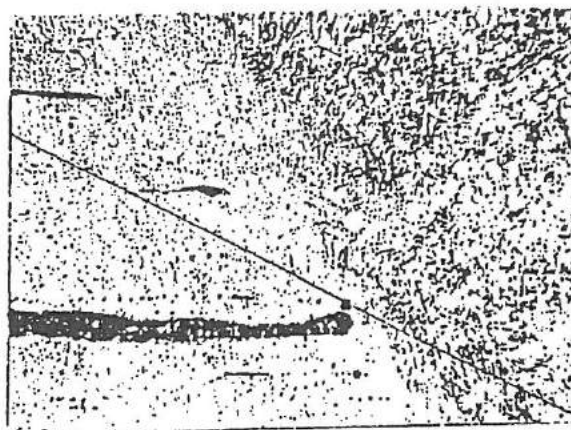
Fig 4

A higher magnification micrograph showing where wrought iron and weld metal appear to have satisfactorily fused without problem is shown in Fig. 4.
