ss Great Britain Project Brief for Preparation of a Condition Report for the ss Great Britain

2.1. The Condition Report will examine the ship known as the ss Great Britain, which is defined as the ship created by I.K Brunel and his collaborators and launched in 1843, until the end of her working life as a ship, hulk or wreck in 1970.

Site visits were conducted to the SS Great Britain, Bristol Historic Dockyard by our engineers on the 29 and 31 July 1998 in order to remove samples of structural material and assess the load bearing wooden supporting struts. In addition to this inspection and testing was carried out to determine the condition of the coffer dam used to secure the dry dock in which the ship is berthed.

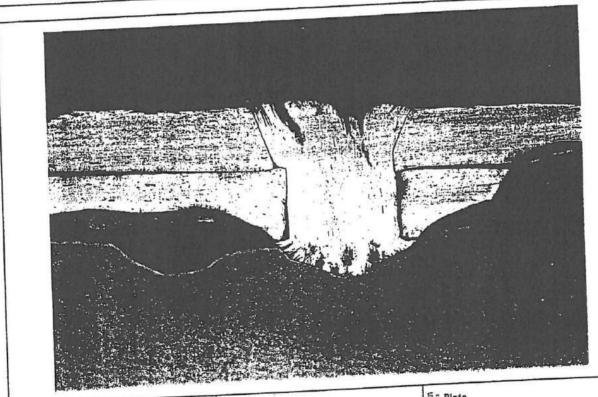
205470.1	Client Ref/Description:		용" Plate	
let Lab Ref:	ME479-1			Etchant:	10% Nital
late No.:	-	Magnification:	x 1.25	Etchant.

Sample ME479-1 showing a typical section through the rivitted connection. This shows the large slag inclusions distributed within the plate and nickel material together with the ingress of corrosion product into the head and point of the rivet.

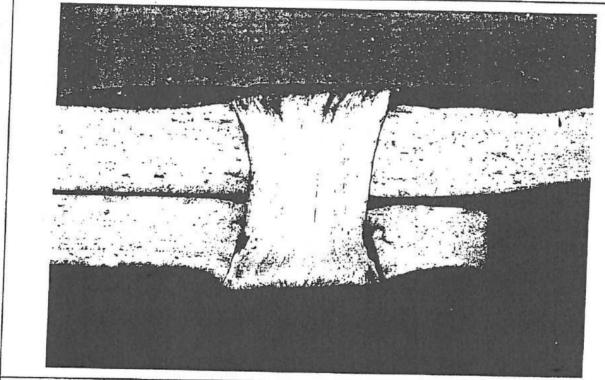
Met Lab Ref: ME480-1 Client Ref/Description: 1" Plate

Sample ME480-1 showing a typical section through the rivitted connection. This shows the large slag inclusions distributed within the plate and nickel material together with the ingress of corrosion product into the head and point of the rivet.

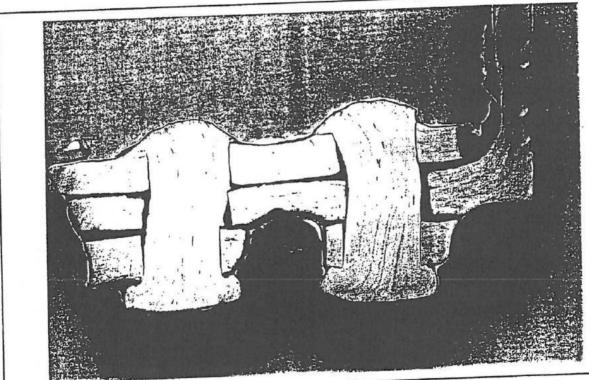
Met Lab Ref: ME481-1		Client Ref/Descrip	tion:	6" x 3" Angle		
Wet Lab her:				10% Nital		
Plate No.:	R	Magnification:	× 1	Etchant:	10 /0 /11

Sample ME481-1 showing a typical section through the rivitted connection. This shows the large slag inclusions distributed within the plate and nickel material together with the ingress of corrosion product into the head and point of the rivet.
