## FENTON HOLLOWAY S.S. GREAT BRITAIN RESTORATION STRUCTURAL AWARDS 2006 SUBMISSION

s.s.great britain restoration

*Client:* ss Great Britain Trust

*Structural engineer (Ship and buildings):* Fenton Holloway

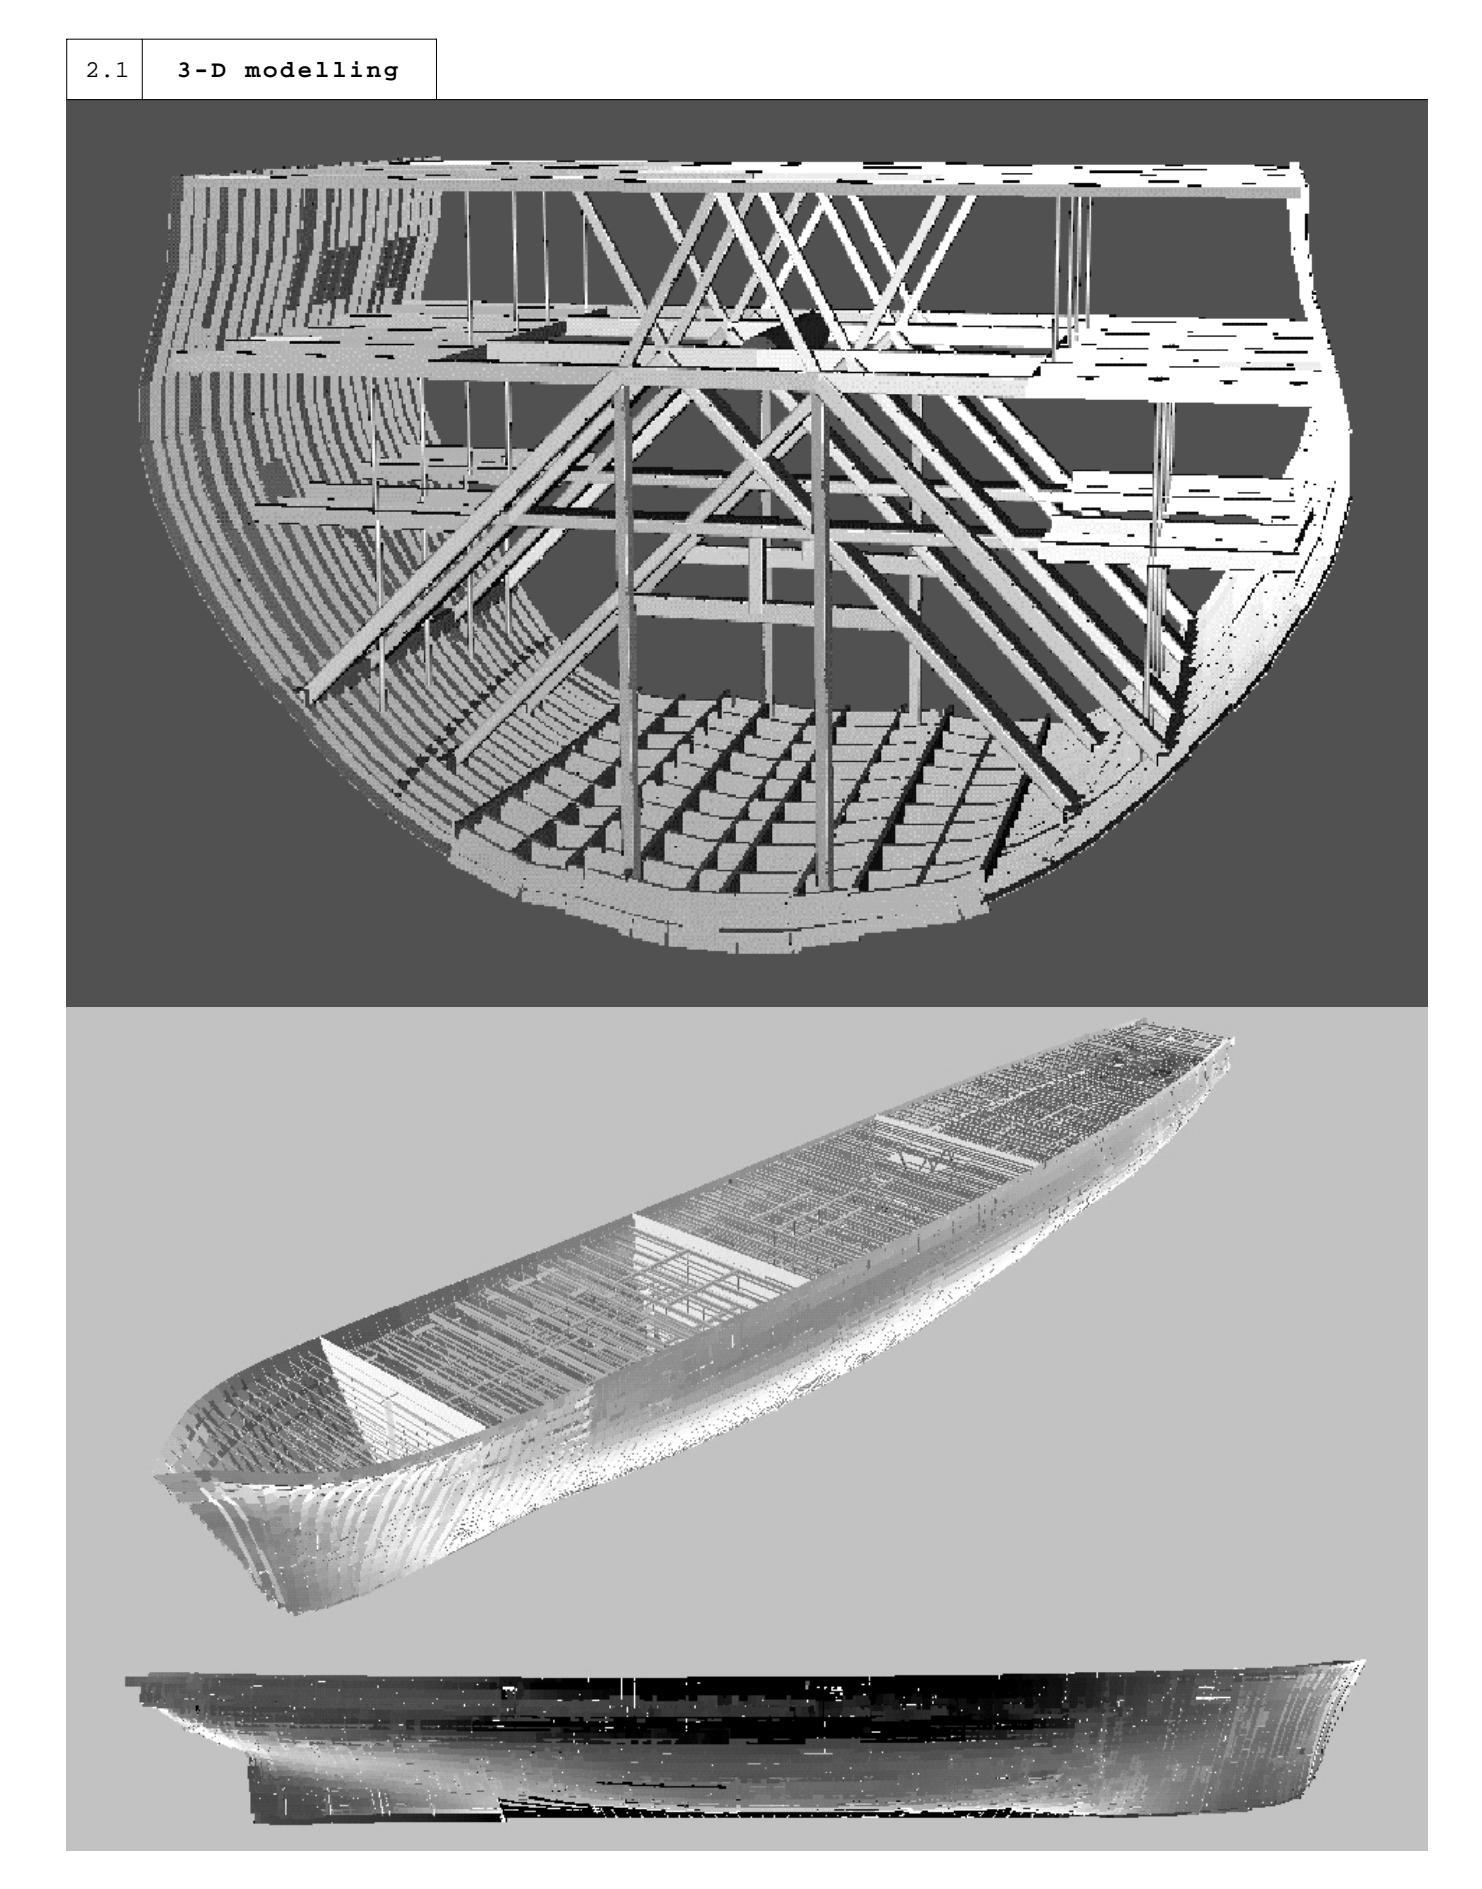
In-house computer modelling combined the photogrammetrically developed hull shell with internally surveyed ribs, posts and beams to produce a working model ready to receive condition survey data.

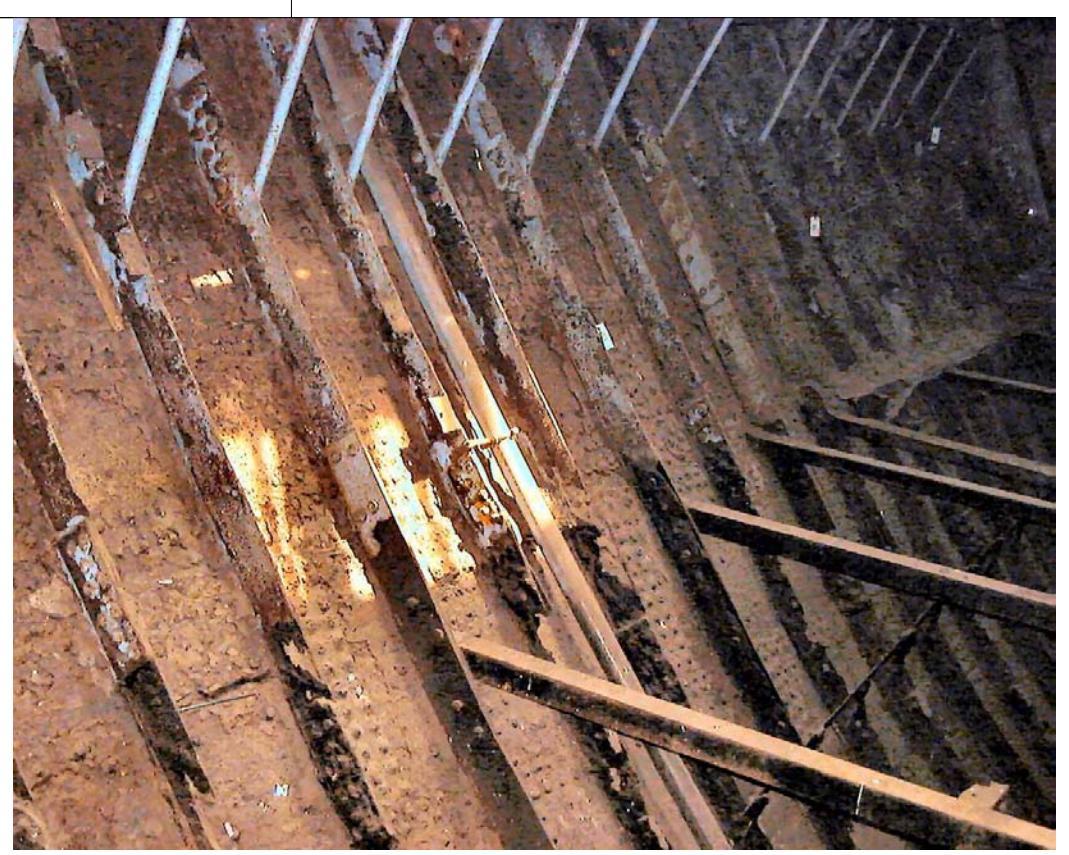
Corrosion products inside the hull were viewed as historic artefacts complicating the process of collecting accurate data.

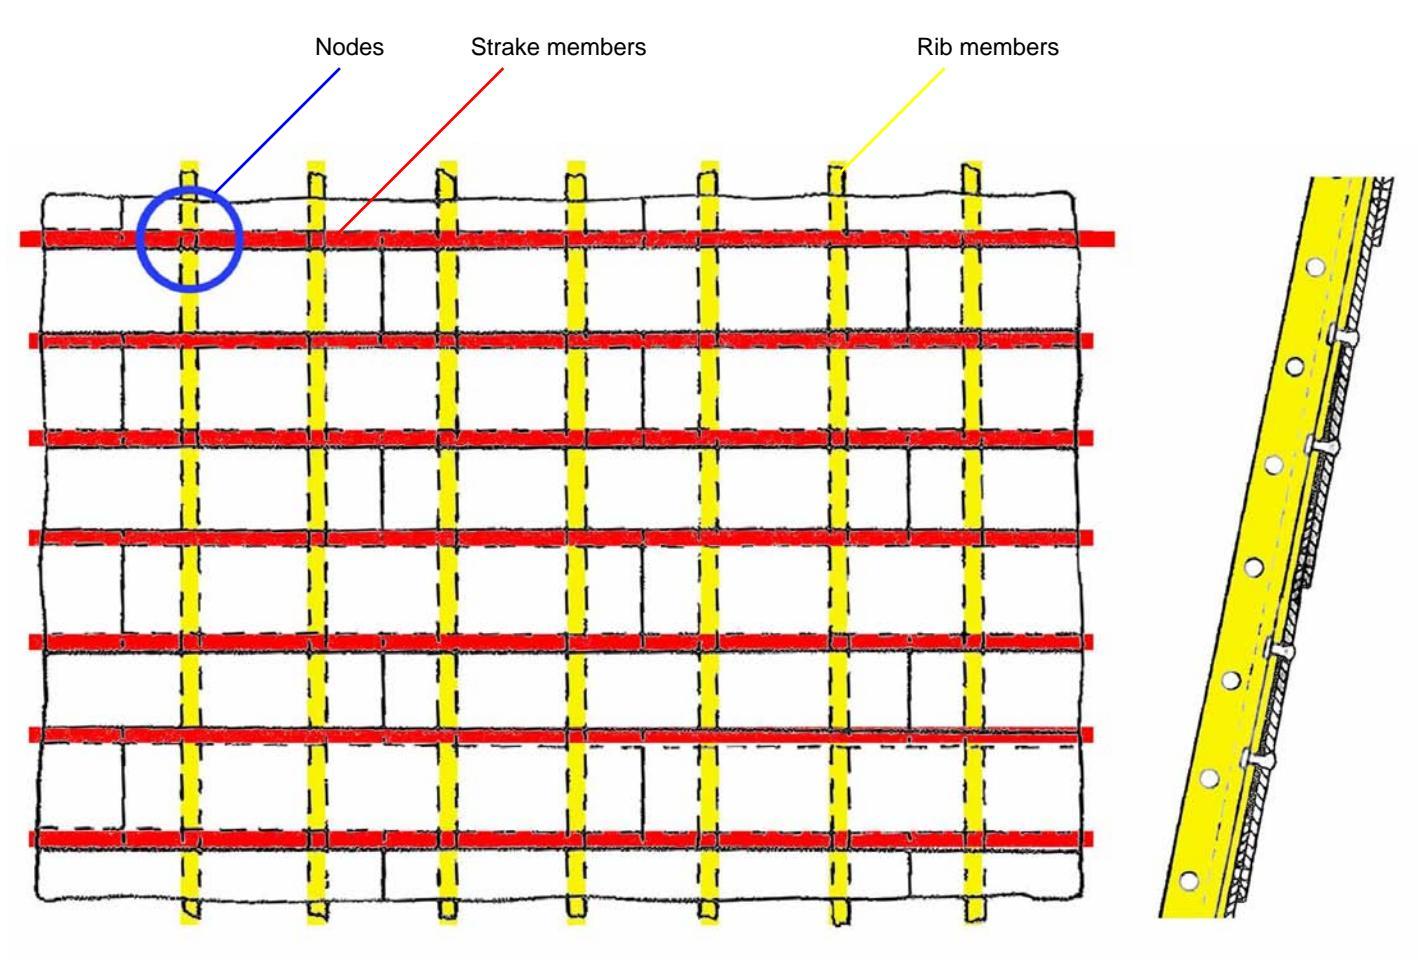
The ship's hull was reduced to a composite grillage system made up of hull plates double thick at overlap locations and ribs.

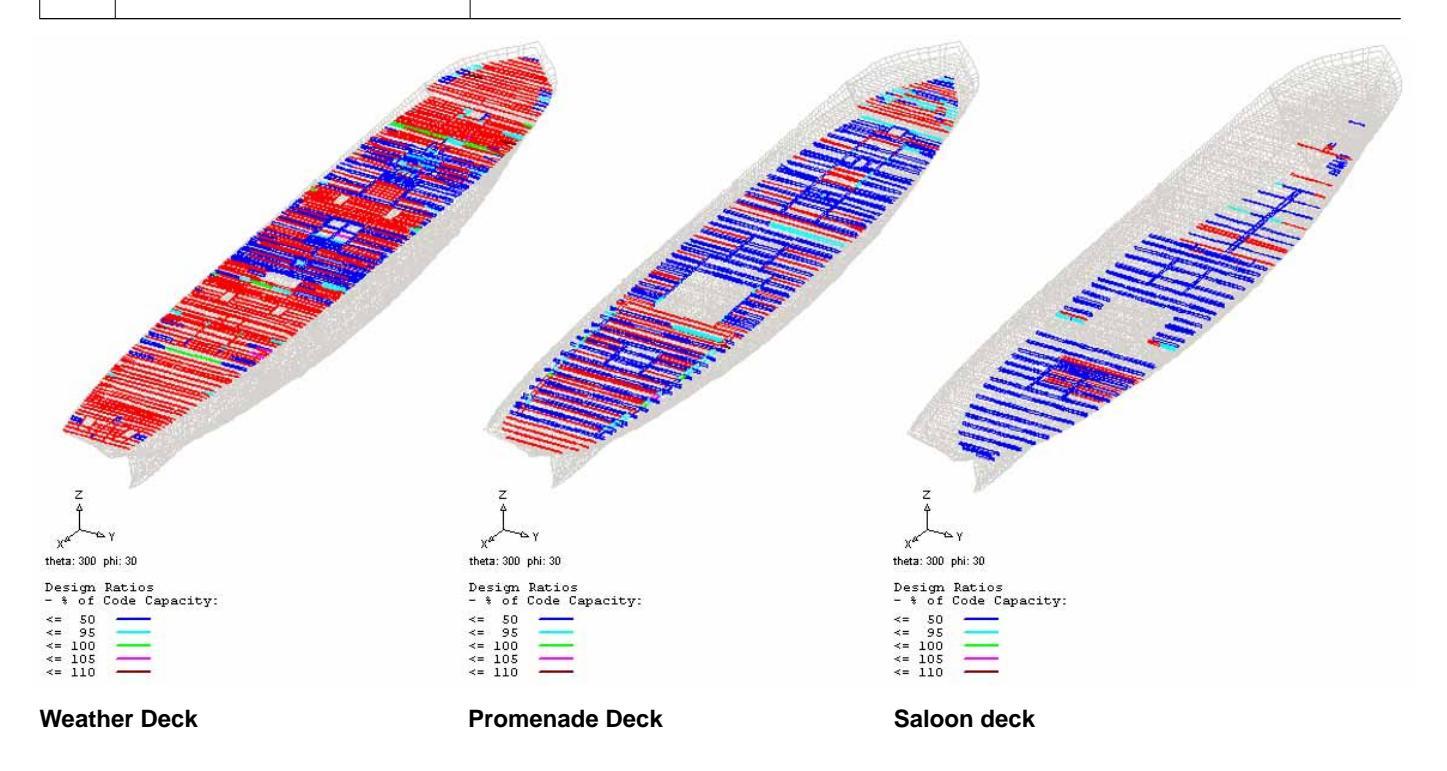
Above: Weather deck overstressing caused by removal of longitudinal members in 1970's - new beams reinstated to original locations.

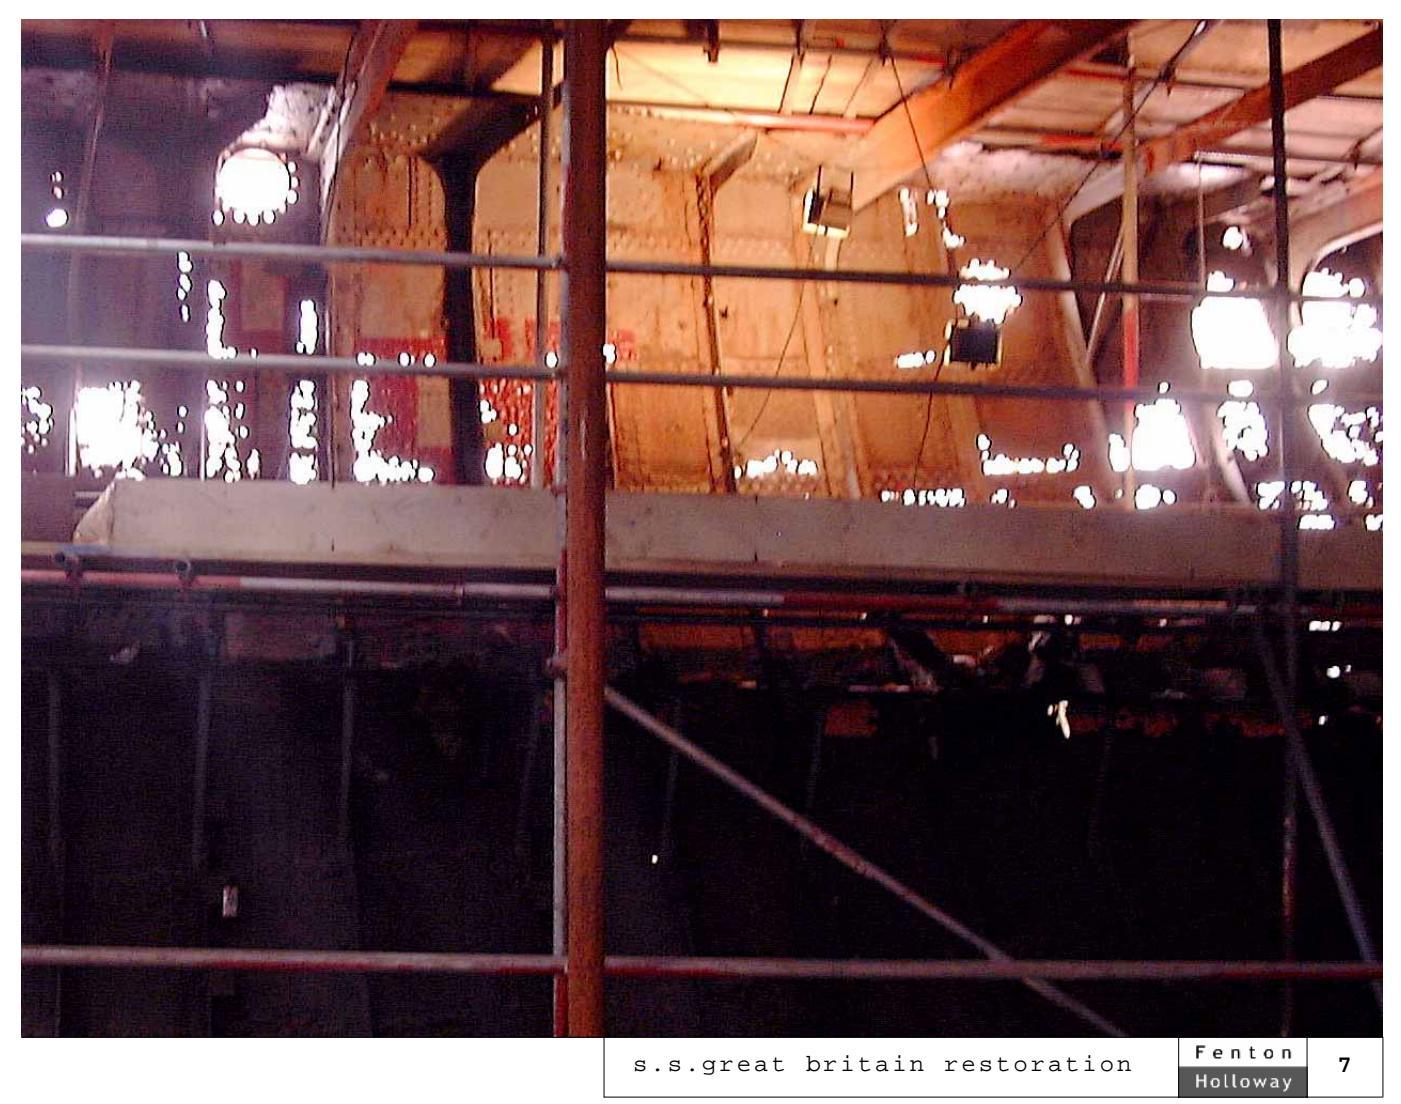
Below: Forward hold corrosion.

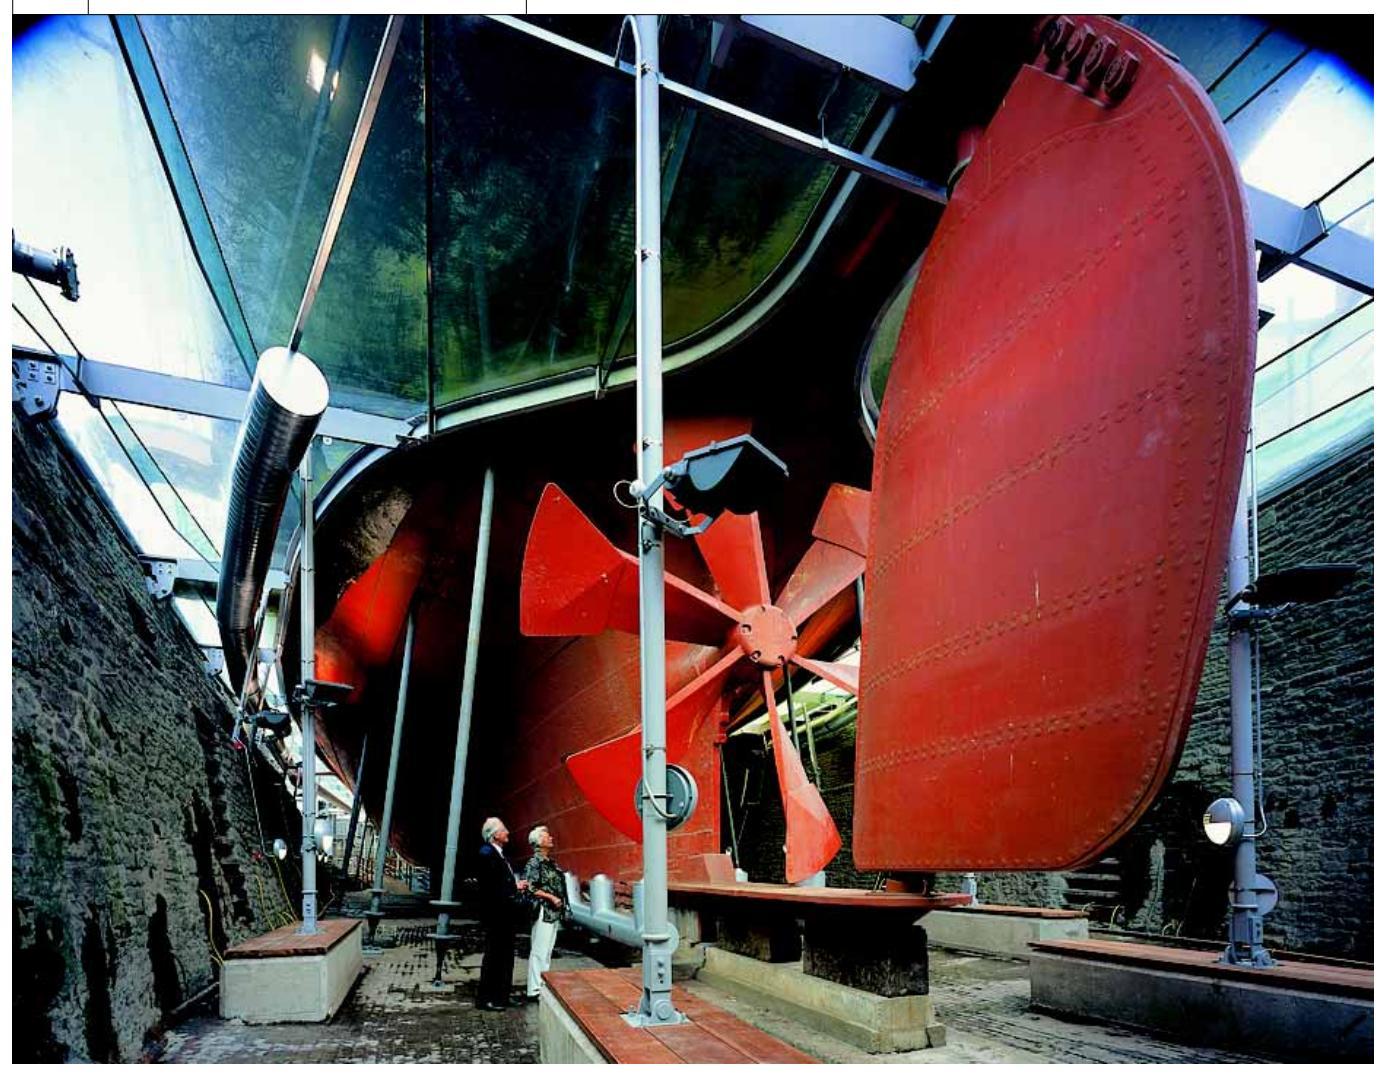
Replica rudder provides key support for overstressed cantilever stern via new internal strut and steel crown arrangement at weather deck level.
